Access Compliance Report

Public Rights-of-Way

(Curb Ramps)

Intersection ID: 28883	Main Street: BALDWIN_HALL_DR	Cross Street: CAMPBELL_HALL_CT	Location: NE
ADA ID: A492B3E38EF3	Ramp Type: Perp	Initial Pass/Fail: Pass	Overall Compliance: No
Severity Score: 7.75			
Codes/Mitigation Info/Possible Solution		Field Measurements/Component Compliance

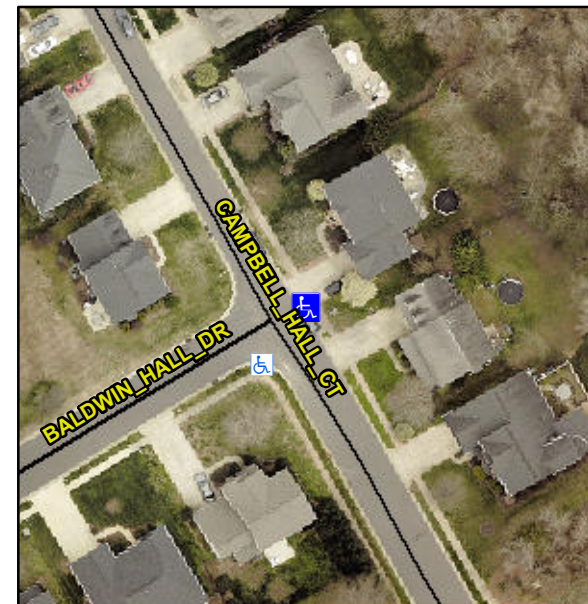
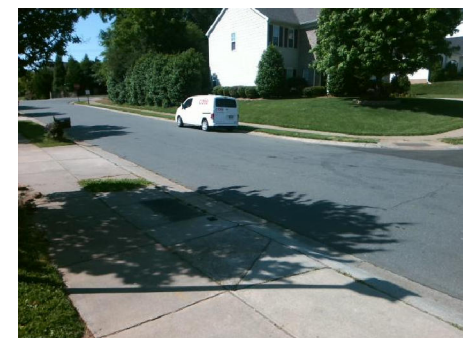
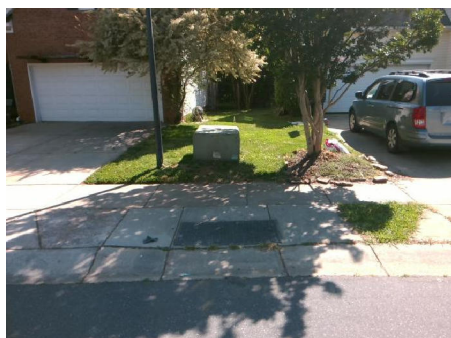
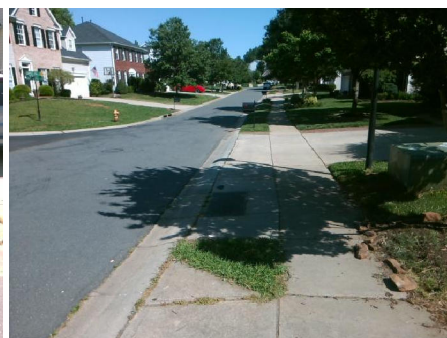
Not Found, R304.5.3, R302.7.2

Compliance	Description	Data	Compliance	Description	Data
N/A	Ramp Length (in)	48.0	Yes	Ramp Slope (%)	6.4
Yes	Ramp Width (in)	48.0	No	Ramp XSlope (%)	3.1
N/A	Flare Type LT	Sloped	N/A	Flare Type RT	N/A
N/A	Flare Slope LT (%)	6.5	Yes	Flare Slope RT (%)	7.8
N/A	Flare Traversable LT?	Yes	N/A	Flare Traversable RT?	Yes
Yes	Landing Length (in)	48.0	Yes	DWS Provided?	Yes
Yes	Landing Width (in)	48.0	Yes	DWS Contrast?	Yes
Yes	Landing Slope (%)	1.7	Yes	DWS Length (in)	24.0
No	Landing X Slope (%)	3.1	Yes	DWS Full Width?	Yes
N/A	Landing Curb? (Y/N)	No	Yes	DWS Offset (in)	2.0
N/A	Shared Landing?	No			
Yes	Gutter Ponding?	No	Yes	Gutter Slope (%)	4.9
No	Gutter Lip Ht (in)	0.5	Yes	Gutter X Slope (%)	1.3
N/A	Painted X Walk1?	No	N/A	Painted X Walk2?	N/A
	X Walk 1 Direction	To SW		X Walk 2 Direction	N/A
N/A	X Walk 1 Width (in)	N/A	N/A	X Walk 2 Width (in)	N/A
	X Walk 1 Slope (%)	2.7		X Walk 2 Slope (%)	N/A
	X Walk 1 X Slope (%)	0.8		X Walk 2 X Slope (%)	N/A

N/A	Ramp inside XWalk1?	N/A	N/A	Ramp inside XWalk2?	N/A
	Road Slope (%)	N/A	N/A	Clear Space?	Yes
	Road X Slope (%)	N/A	N/A	Clear Space to XWalk (in)	N/A
Yes	Any Obstructions?	No	Yes	Storm Grate/Utility Hazard?	No
	Obstruction Type			Storm Grate/Utility Type	
		N/A			N/A
			Yes	Surface Condition? (G/P)	Good

Remove & Replace Entire Ramp.

Total Cost: \$ 1850.00
