Access Compliance Report

Public Rights-of-Way

(Curb Ramps)

Intersection ID: N/A	Main Street: NINA_DR	Cross Street: W_T_HARRIS_BV	Location: SW
ADA ID: A498C0F47973	Ramp Type: Para	Initial Pass/Fail: Fail	Overall Compliance: No
Codes/Mitigation Info/Possible Solution		Field Measurements/Component Compliance	
Severity Score: 12.5

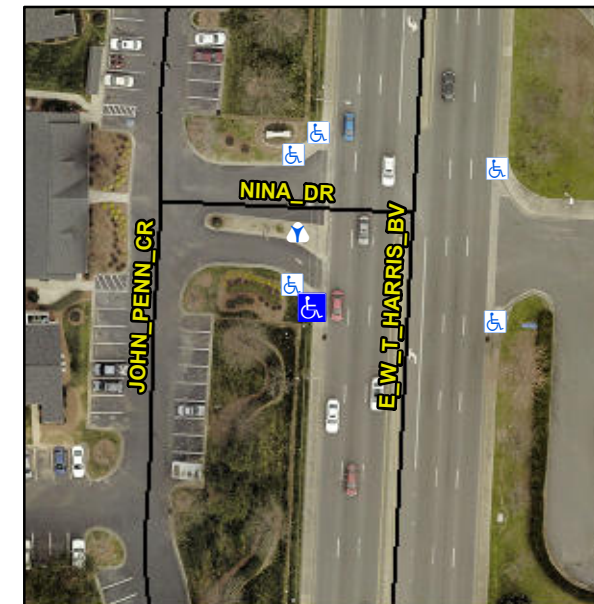
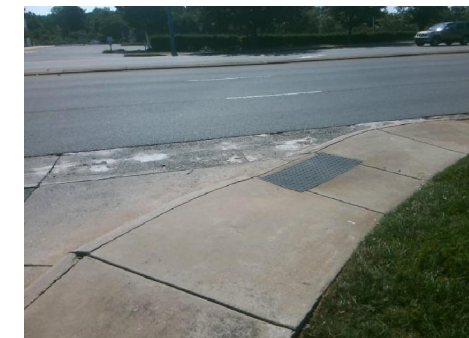
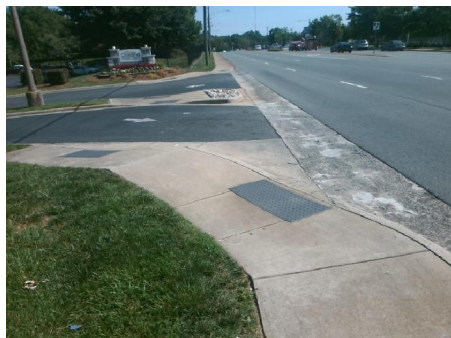
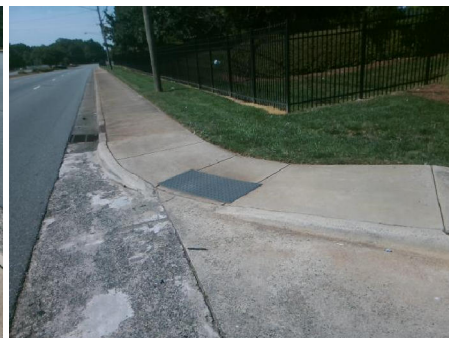
MEDIAN ACROSS W T HARRIS BV

Compliance	Description	Data	Compliance	Description	Data
N/A	Ramp Length LT (in)	34.0	N/A	Ramp Length RT (in)	67.0
Yes	Ramp Width LT (in)	61.0	Yes	Ramp Width RT (in)	60.0
No	Ramp Slope LT (%)	11.6	No	Ramp Slope RT (%)	10.1
Yes	Ramp XSlope LT (%)	1.8	Yes	Ramp XSlope RT (%)	0.1
N/A	Landing Length (in)	N/A	N/A	DWS Provided?	N/A
N/A	Landing Width (in)	N/A	N/A	DWS Contrast?	N/A
N/A	Landing Slope (%)	N/A	N/A	DWS Length (in)	N/A
N/A	Landing X Slope (%)	N/A	N/A	DWS Full Width?	N/A
N/A	Landing Curb? (Y/N)	N/A	N/A	DWS Offset (in)	N/A
N/A	Shared Landing?	N/A			
N/A	Gutter Ponding?	N/A	N/A	Gutter Slope (%)	N/A
N/A	Gutter Lip Ht (in)	N/A	N/A	Gutter X Slope (%)	N/A
N/A	Painted X Walk1?	No	N/A	Painted X Walk2?	N/A
	X Walk 1 Direction	To E		X Walk 2 Direction	N/A
N/A	X Walk 1 Width (in)	N/A	N/A	X Walk 2 Width (in)	N/A
	X Walk 1 Slope (%)	1.4		X Walk 2 Slope (%)	N/A
	X Walk 1 X Slope (%)	0.8		X Walk 2 X Slope (%)	N/A
N/A	Ramp inside XWalk1?	N/A	N/A	Ramp inside XWalk2?	N/A

Road Slope (%)	N/A	N/A	Clear Space?	N/A
	Road X Slope (%)	N/A	N/A	Clear Space to XWalk (in)	N/A
N/A	Any Obstructions?	N/A	N/A	Storm Grate/Utility Hazard?	N/A
	Obstruction Type			Storm Grate/Utility Type	
		N/A			N/A
			Yes	Surface Condition? (G/P)	Good
			N/A	Curb Slope (%)	2.9

Possible Solutions:

Remove & Replace Entire Ramp.

R304.3.2
