Access Compliance Report

Public Rights-of-Way

(Curb Ramps)

Intersection ID: 31765	Main Street: FIRST_RUN_CT	Cross Street: PINYON_PINE_LN	Location: E
ADA ID: A4A70B1D0860	Ramp Type: Combination2	Initial Pass/Fail: Fail	Overall Compliance: No
		Severity Score: 22.5

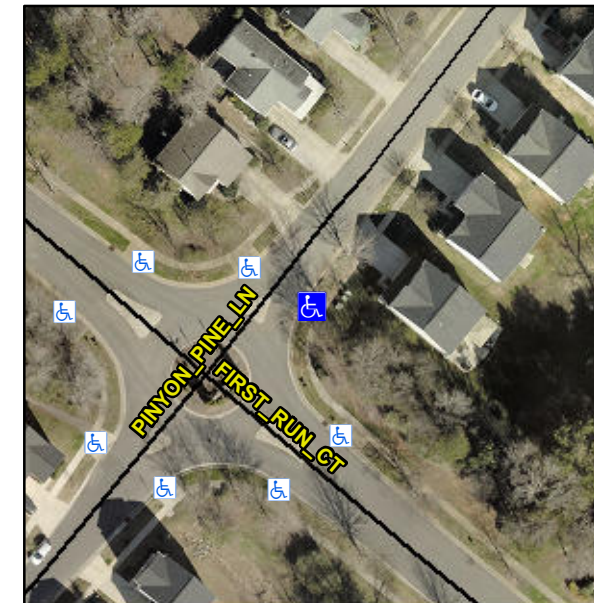
RT RP < 5%

Not Found, R304.5.1, R304.3.2, R304.5.3

Compliance	Description	Data	Compliance	Description	Data
N/A	Ramp Length LT (in)	40.5	N/A	Ramp Length RT (in)	47.0
Yes	Ramp Width LT (in)	48.0	N/A	Ramp Width RT (in)	47.0
No	Ramp Slope LT (%)	9.1	N/A	Ramp Slope RT (%)	0.9
No	Ramp XSlope LT (%)	4.3	N/A	Ramp XSlope RT (%)	1.1
N/A	Ramp Length (in)	82.0	Yes	Ramp Slope (%)	5.5
No	Ramp Width (in)	47.0	Yes	Ramp XSlope (%)	1.1
N/A	Flare Type LT	N/A	N/A	Flare Type RT	N/A
N/A	Flare Slope LT (%)	N/A	N/A	Flare Slope RT (%)	N/A
N/A	Flare Traversable LT?	N/A	N/A	Flare Traversable RT?	N/A
N/A	Landing Length (in)	N/A	N/A	DWS Provided?	N/A
N/A	Landing Width (in)	N/A	N/A	DWS Contrast?	N/A
N/A	Landing Slope (%)	N/A	N/A	DWS Length (in)	N/A
N/A	Landing X Slope (%)	N/A	N/A	DWS Full Width?	N/A
N/A	Landing Curb? (Y/N)	N/A	N/A	DWS Offset (in)	N/A
N/A	Shared Landing?	N/A			
N/A	Gutter Ponding?	N/A	N/A	Gutter Slope (%)	N/A
N/A	Gutter Lip Ht (in)	N/A	N/A	Gutter X Slope (%)	N/A
N/A	Painted X Walk1?	No	N/A	Painted X Walk2?	N/A

Remove & Replace Entire Ramp.
