Access Compliance Report

Public Rights-of-Way

(Curb Ramps)

Intersection ID: 10332	Main Street: ANDERSON_ST	Cross Street: OAKWOOD_AV	Location: SW
ADA ID: A4A8EE48303C	Ramp Type: Perp	Initial Pass/Fail: Fail	Overall Compliance: No
Severity Score: 33.75			
Codes/Mitigation Info/Possible Solution		Field Measurements/Component Compliance

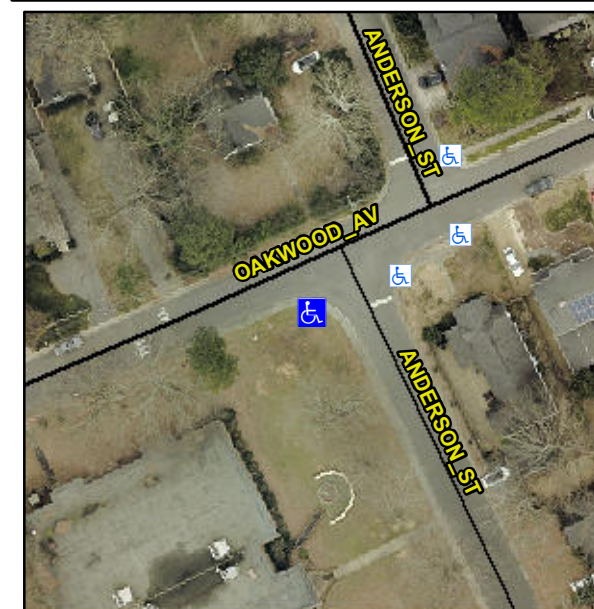
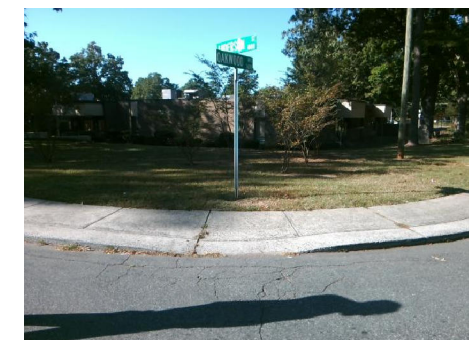
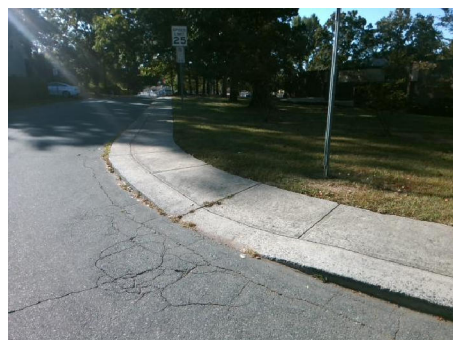
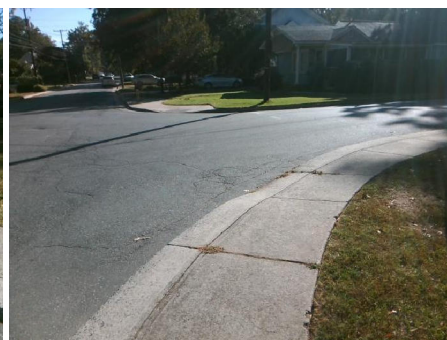
Not Found, R304.5.1, R304.2.2

Compliance	Description	Data	Compliance	Description	Data
N/A	Ramp Length (in)	38.0	No	Ramp Slope (%)	15.0
No	Ramp Width (in)	45.5	Yes	Ramp XSlope (%)	2.0
N/A	Flare Type LT	N/A	N/A	Flare Type RT	N/A
N/A	Flare Slope LT (%)	N/A	N/A	Flare Slope RT (%)	N/A
N/A	Flare Traversable LT?	N/A	N/A	Flare Traversable RT?	N/A
N/A	Landing Length (in)	N/A	N/A	DWS Provided?	N/A
N/A	Landing Width (in)	N/A	N/A	DWS Contrast?	N/A
N/A	Landing Slope (%)	N/A	N/A	DWS Length (in)	N/A
N/A	Landing X Slope (%)	N/A	N/A	DWS Full Width?	N/A
N/A	Landing Curb? (Y/N)	N/A	N/A	DWS Offset (in)	N/A
N/A	Shared Landing?	N/A			
N/A	Gutter Ponding?	N/A	N/A	Gutter Slope (%)	N/A
N/A	Gutter Lip Ht (in)	N/A	N/A	Gutter X Slope (%)	N/A
N/A	Painted X Walk1?	No	N/A	Painted X Walk2?	N/A
	X Walk 1 Direction	To E		X Walk 2 Direction	N/A
N/A	X Walk 1 Width (in)	N/A	N/A	X Walk 2 Width (in)	N/A
	X Walk 1 Slope (%)	2.6		X Walk 2 Slope (%)	N/A
	X Walk 1 X Slope (%)	1.0		X Walk 2 X Slope (%)	N/A

N/A	Ramp inside XWalk1?	N/A	N/A	Ramp inside XWalk2?	N/A
	Road Slope (%)	N/A	N/A	Clear Space?	N/A
	Road X Slope (%)	N/A	N/A	Clear Space to XWalk (in)	N/A
N/A	Any Obstructions?	N/A	N/A	Storm Grate/Utility Hazard?	N/A
	Obstruction Type			Storm Grate/Utility Type	
		N/A			N/A
			Yes	Surface Condition? (G/P)	Good

Remove & Replace Entire Ramp.

Total Cost: \$ 1850.00
