Access Compliance Report Public Rights-of-Way (Curb Ramps)

Intersection ID: 47384	ection ID: 47384 Main Street: BRIDGEWALK_DR			Cross	Street:	ARDREY_KELL_RD	Location:	NW		
ADA ID: A4BBD44F29CE	044F29CE Ramp Type: PerpDiag			Initial	Pass/Fa	ail: Fail Overall	o Severity Score:	10		
Codes/Mitigation Info/Possible Solution					Field Measurements/Component Compliance					
		Possible Solutions:			Compliance Description		Data	Comp	liance Description	Data
		Remove & Replace Curb F	Ramr	With	N/A	Ramp Length (in)	47.0	Yes	Ramp Slope (%)	7.8
		Two New Directional Ram	-		No	Ramp Width (in)	45.0		Ramp XSlope (%)	3.0
		Equivalent.	P • • •		N/A	Flare Type LT	N/A		Flare Type RT	N/A
		3			N/A	Flare Slope LT (%)		N/A	Flare Slope RT (%)	N/A
Jam Re					N/A	Flare Traversable LT?	N/A		Flare Traversable RT?	N/A
3 and - Same				N/A	Landing Length (in)		N/A	DWS Provided?	N/A	
	Surveyor Notes:			N/A	Landing Width (in)	N/A	N/A	DWS Contrast?	N/A

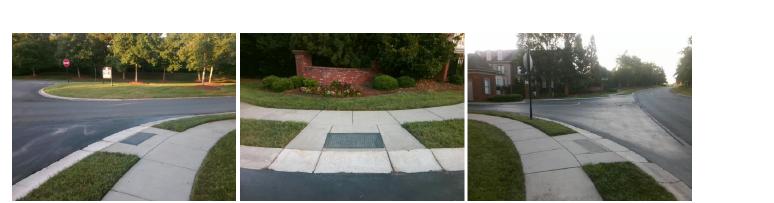
R. A.	N/A			N/A	Landing Slope (%)		N/A	DWS Length (in)	N/A	
All all and the second	0/8			N/A	Landing X Slope (%)	N/A		DWS Full Width?	N/A	
PROW/ADA:				N/A	Landing Curb? (Y/N)	N/A		DWS Offset (in)	N/A	
				N/A	Shared Landing?	N/A		2		
					N/A	Gutter Ponding?	N/A	N/A	Gutter Slope (%)	N/A
				N/A	Gutter Lip Ht (in)	N/A		Gutter X Slope (%)	N/A	
Not Found, R304.5.1, R304.5.3					N/A	Painted X Walk1?	No	N/A	Painted X Walk2?	No
					N/A	X Walk 1 Direction	To S		X Walk 2 Direction	To E
				N/A	X Walk 1 Width (in)	N/A	N/A	X Walk 2 Width (in)	N/A	
Street 1 Name	ARDREY KELL RD	-			N/A	X Walk 1 Slope (%)	1.2		X Walk 2 Slope (%)	5.3
Stop Condition-Street 2	None					X Walk 1 X Slope (%)	2.6		X Walk 2 X Slope (%)	0.3
Street 2 Name	BRIDGEWALK DR				N/A	Ramp inside XWalk1?		N/A	Ramp inside XWalk2?	N/A
Stop Condition-Street 1	StopSign				N/A	Road Slope (%)	3.2		Clear Space?	N/A
	otopolyn					Road X Slope (%)	1.7	N/A	Clear Space to XWalk (in)	N/A

N/A	Any Obstructions?	N/A		Storm Grate/Utility Hazard?	N/A
		Total Cost:	\$	3200.00	11/5	Obstruction Type	N/A		Storm Grate/Utility Type	11/2
			Ψ	5200.00			N/A		Storm Oraco/Ounty Type	N/A
							IN/A			11/1
