Access Compliance Report

Public Rights-of-Way

(Curb Ramps)

Intersection ID: 46930	Main Street: SUTTER_CREEK_LN	Cross Street: LIVERMORE_LN	Location: SW
ADA ID: A4C4B092B066	Ramp Type: BlendTrans2	Initial Pass/Fail: Fail	Overall Compliance: No
		Severity Score: 12.5

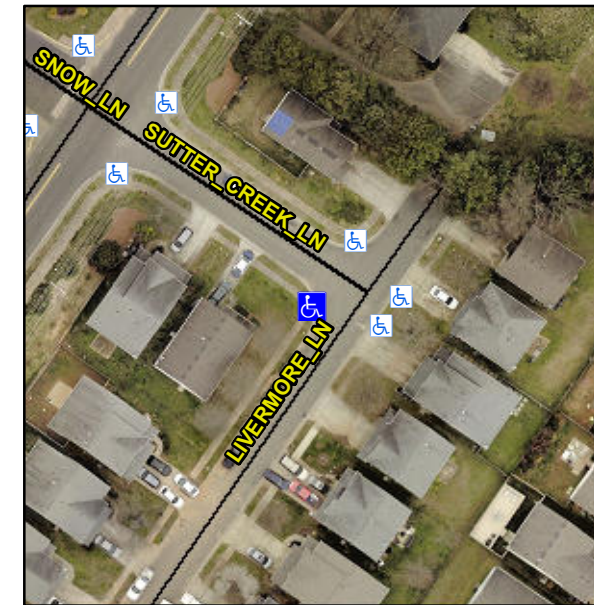
Not Found, R304.5.3

Compliance	Description	Data	Compliance	Description	Data
N/A	Ramp Length (in)	96.0	Yes	BlendTrans Slope (%)	3.7
Yes	Ramp Width (in)	48.0	No	BlendTrans XSlope (%)	5.3
N/A	Flare Type LT	N/A	N/A	Flare Type RT	N/A
N/A	Flare Slope LT (%)	N/A	N/A	Flare Slope RT (%)	N/A
N/A	Flare Traversable LT?	N/A	N/A	Flare Traversable RT?	N/A
N/A	Landing Length (in)	N/A	N/A	DWS Provided?	N/A
N/A	Landing Width (in)	N/A	N/A	DWS Contrast?	N/A
N/A	Landing Slope (%)	N/A	N/A	DWS Length (in)	N/A
N/A	Landing X Slope (%)	N/A	N/A	DWS Full Width?	N/A
N/A	Landing Curb? (Y/N)	N/A	N/A	DWS Offset (in)	N/A
N/A	Shared Landing?	N/A			
N/A	Gutter Ponding?	N/A	N/A	Gutter Slope (%)	N/A
N/A	Gutter Lip Ht (in)	N/A	N/A	Gutter X Slope (%)	N/A
N/A	Painted X Walk1?	No	N/A	Painted X Walk2?	No
	X Walk 1 Direction	To SE		X Walk 2 Direction	To NE
	X Walk 1 Width (in)	N/A		X Walk 2 Width (in)	N/A
	X Walk 1 Slope (%)	1.8		X Walk 2 Slope (%)	0.5
	X Walk 1 X Slope (%)	0.4		X Walk 2 X Slope (%)	0.9

N/A	Ramp inside XWalk1?	N/A	N/A	Ramp inside XWalk2?	N/A
	Road Slope (%)	2.8		Clear Space?	N/A
	Road X Slope (%)	3.1	N/A	Clear Space to XWalk (in)	N/A
N/A	Any Obstructions?	N/A	N/A	Storm Grate/Utility Hazard?	N/A
	Obstruction Type			Storm Grate/Utility Type	
		N/A			N/A
			Yes	Surface Condition? (G/P)	Good
			No	Curb Slope (%)	8.6

Remove & Replace Curb Ramp With Two New Directional Ramps or Equivalent.
