Access Compliance Report

Public Rights-of-Way

(Curb Ramps)

Intersection ID: N/A	Main Street: INDEPENDENCE_RD	Cross Street: N/A	Location: N
ADA ID: A4C6800B23FE	Ramp Type: PerpDiag	Initial Pass/Fail: Fail	Overall Compliance: No
Severity Score: 22.5			
Codes/Mitigation Info/Possible Solution		Field Measurements/Component Compliance

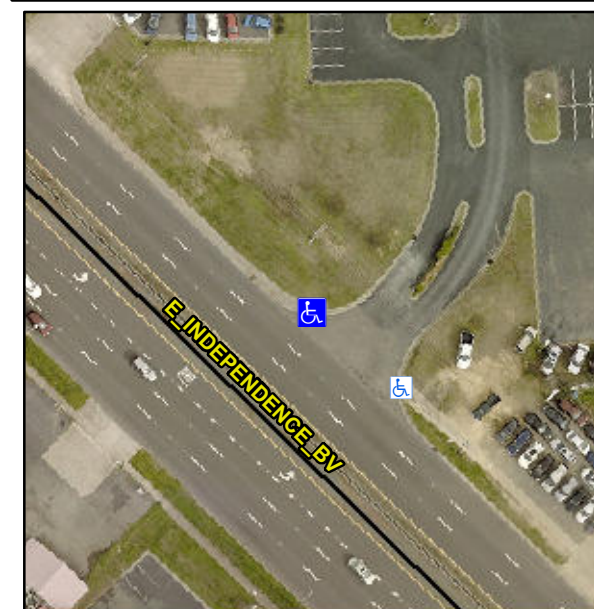
R304.5.1, R304.2.2

Compliance	Description	Data	Compliance	Description	Data
N/A	Ramp Length (in)	54.0	No	Ramp Slope (%)	9.6
No	Ramp Width (in)	41.0	Yes	Ramp XSlope (%)	2.5
N/A	Flare Type LT	N/A	N/A	Flare Type RT	N/A
N/A	Flare Slope LT (%)	N/A	N/A	Flare Slope RT (%)	N/A
N/A	Flare Traversable LT?	N/A	N/A	Flare Traversable RT?	N/A
N/A	Landing Length (in)	N/A	N/A	DWS Provided?	N/A
N/A	Landing Width (in)	N/A	N/A	DWS Contrast?	N/A
N/A	Landing Slope (%)	N/A	N/A	DWS Length (in)	N/A
N/A	Landing X Slope (%)	N/A	N/A	DWS Full Width?	N/A
N/A	Landing Curb? (Y/N)	N/A	N/A	DWS Offset (in)	N/A
N/A	Shared Landing?	N/A			
N/A	Gutter Ponding?	N/A	N/A	Gutter Slope (%)	N/A
N/A	Gutter Lip Ht (in)	N/A	N/A	Gutter X Slope (%)	N/A
N/A	Painted X Walk1?	No	N/A	Painted X Walk2?	No
	X Walk 1 Direction	To SW		X Walk 2 Direction	To SE
N/A	X Walk 1 Width (in)	N/A	N/A	X Walk 2 Width (in)	N/A
	X Walk 1 Slope (%)	5.6		X Walk 2 Slope (%)	4.2
	X Walk 1 X Slope (%)	3.3		X Walk 2 X Slope (%)	5.8

N/A	Ramp inside XWalk1?	N/A	N/A	Ramp inside XWalk2?	N/A
	Road Slope (%)	4.0	N/A	Clear Space?	N/A
	Road X Slope (%)	7.2	N/A	Clear Space to XWalk (in)	N/A
N/A	Any Obstructions?	N/A	N/A	Storm Grate/Utility Hazard?	N/A
	Obstruction Type			Storm Grate/Utility Type	
		N/A			N/A
			Yes	Surface Condition? (G/P)	Good

Possible Solutions:

Remove & Replace Curb Ramp With Two New Directional Ramps or Equivalent.

Total Cost: \$ 3200.00
