Access Compliance Report

Public Rights-of-Way

(Curb Ramps)

Intersection ID: N/A	Main Street: WILTHSHIRE_MANOR_DR	Cross Street: LADBROKE_CT	Location: SE
ADA ID: A4D4D11ADF06	Ramp Type: Directional1	Initial Pass/Fail: Fail	Overall Compliance: No
Codes/Mitigation Info/Possible Solution			Severity Score: 10
			Field Measurements/Component Compliance

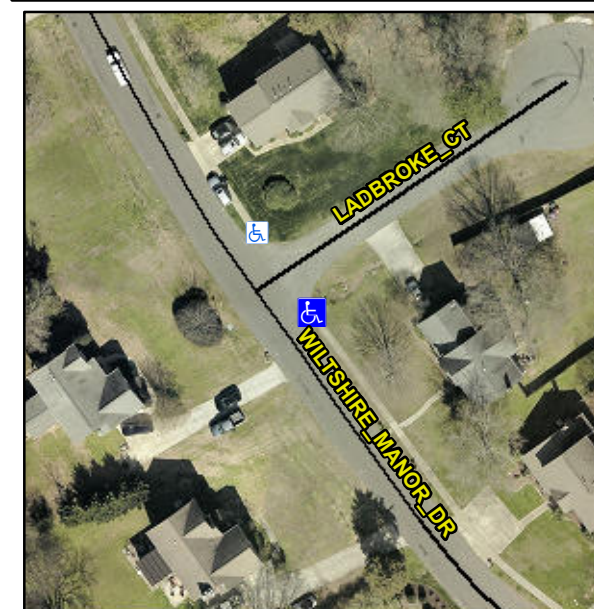
Compliance	Description	Data	Compliance	Description	Data
N/A	Ramp Length (in)	47.0	N/A	Grade Break?	N/A
No	Ramp Width (in)	43.5	N/A	Grade Break Slope (%)	0.0
Yes	Ramp Slope (%)	1.6	N/A	Grade Break XSlope (%)	0.0
No	Ramp XSlope (%)	2.5			
N/A	Flare Type LT	N/A	N/A	Flare Type RT	N/A
N/A	Flare Slope LT (%)	N/A	N/A	Flare Slope RT (%)	0.0
N/A	Flare Traversable LT?	N/A	N/A	Flare Traversable RT?	N/A
N/A	Landing Length (in)	0.0	N/A	DWS Provided?	N/A
N/A	Landing Width (in)	0.0	N/A	DWS Contrast?	N/A
N/A	Landing Slope (%)	0.0	N/A	DWS Length (in)	N/A
N/A	Landing X Slope (%)	0.0	N/A	DWS Full Width?	N/A
N/A	Landing Curb? (Y/N)	N/A	N/A	DWS Offset LT (in)	N/A
N/A	Shared Landing?	N/A	N/A	DWS Offset RT (in)	N/A
N/A	Gutter Ponding?	0.0	N/A	Gutter Slope (%)	N/A
N/A	Gutter Lip Ht (in)	0.0	N/A	Gutter X Slope (%)	N/A
N/A	Painted X Walk1?	No		Road Slope (%)	0.5
	X Walk 1 Direction	To NW		Road X Slope (%)	2.1
	X Walk 1 Width (in)	N/A		Clear Space?	N/A

X Walk 1 Slope (%)	0.5	N/A	Clear Space to XWalk (in)	N/A
	X Walk 1 X Slope (%)	2.1	N/A	Storm Grate/Utility Hazard?	N/A
N/A	Ramp inside XWalk1?	N/A		Storm Grate/Utility Type	
N/A	Any Obstructions?	N/A			N/A
	Obstruction Type		Yes	Surface Condition? (G/P)	Good
			N/A	Curb Slope (%)	0.7

Possible Solutions:

Remove & Replace Entire Ramp.

PROW/ADA:

R304.5.1, R304.5.3
