# Access Compliance Report

## Public Rights-of-Way

### (Curb Ramps)

Intersection ID: 12433	Main Street: HARGROVE_AV	Cross Street: MIDLAND_AV	Location: SW
ADA ID: A4DB7142C85D	Ramp Type: PerpDiag	Initial Pass/Fail: Fail	Overall Compliance: No
		Severity Score: 22.5

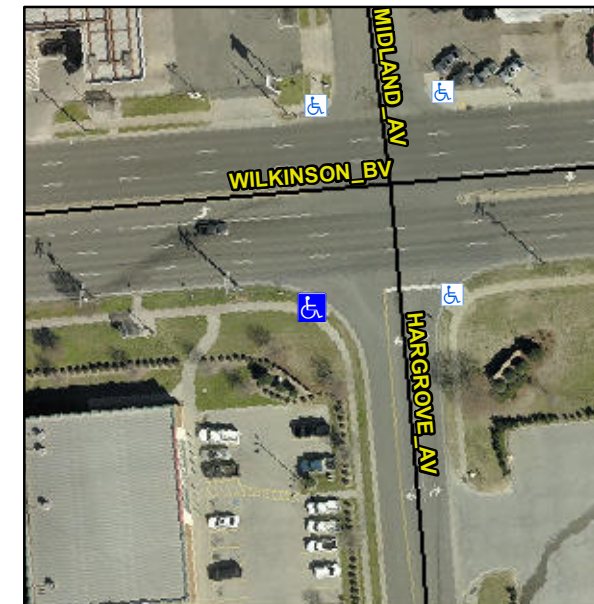
**Not Found, R304.5.1, R304.2.2, R304.5.3**

Compliance	Description	Data	Compliance	Description	Data
N/A	Ramp Length (in)	60.0	No	Ramp Slope (%)	9.2
No	Ramp Width (in)	43.0	No	Ramp XSlope (%)	2.2
N/A	Flare Type LT	N/A	N/A	Flare Type RT	N/A
N/A	Flare Slope LT (%)	N/A	N/A	Flare Slope RT (%)	N/A
N/A	Flare Traversable LT?	N/A	N/A	Flare Traversable RT?	N/A
N/A	Landing Length (in)	N/A	N/A	DWS Provided?	N/A
N/A	Landing Width (in)	N/A	N/A	DWS Contrast?	N/A
N/A	Landing Slope (%)	N/A	N/A	DWS Length (in)	N/A
N/A	Landing X Slope (%)	N/A	N/A	DWS Full Width?	N/A
N/A	Landing Curb? (Y/N)	N/A	N/A	DWS Offset (in)	N/A
N/A	Shared Landing?	N/A			
N/A	Gutter Ponding?	N/A	N/A	Gutter Slope (%)	N/A
N/A	Gutter Lip Ht (in)	N/A	N/A	Gutter X Slope (%)	N/A
N/A	Painted X Walk1?	No	N/A	Painted X Walk2?	No
	X Walk 1 Direction	To E		X Walk 2 Direction	To N
N/A	X Walk 1 Width (in)	N/A	N/A	X Walk 2 Width (in)	N/A
	X Walk 1 Slope (%)	2.7		X Walk 2 Slope (%)	3.9
	X Walk 1 X Slope (%)	4.2		X Walk 2 X Slope (%)	1.8

N/A	Ramp inside XWalk1?	N/A	N/A	Ramp inside XWalk2?	N/A
	Road Slope (%)	2.1	N/A	Clear Space?	N/A
	Road X Slope (%)	5.2	N/A	Clear Space to XWalk (in)	N/A
N/A	Any Obstructions?	N/A	N/A	Storm Grate/Utility Hazard?	N/A
	Obstruction Type			Storm Grate/Utility Type	
		N/A			N/A
			Yes	Surface Condition? (G/P)	Good

**Remove & Replace Curb Ramp With Two New Directional Ramps or Equivalent.**

Total Cost: \$ 3200.00
