Access Compliance Report Public Rights-of-Way (Curb Ramps)

Intersection ID: 28536 Main Street: SOUTH STREAM BV Cross Street: W_TYVOLA_RD Location: ADA ID: A4E0959625B3 Ramp Type: BlendTrans2 Initial Pass/Fail: Fail **Overall Compliance: No Severity Score:** 10

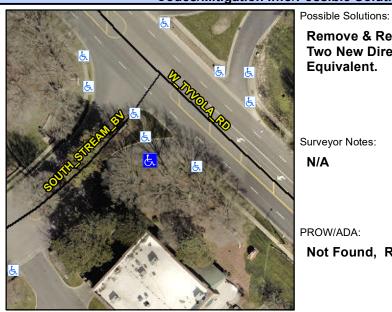
Not Found, R304.5.1, R304.5.3

Field Measurements/Component Compliance						
	Compliance Description		Data	Compliance Description		Data
	N/A	Ramp Length (in)	60.0	Yes	BlendTrans Slope (%)	3.4
	No	Ramp Width (in)	47.0	No	BlendTrans XSlope (%)	2.4
	N/A	Flare Type LT	N/A	N/A	Flare Type RT	N/A
	N/A	Flare Slope LT (%)	N/A	N/A	Flare Slope RT (%)	N/A
	N/A	Flare Traversable LT?	N/A	N/A	Flare Traversable RT?	N/A
	N/A	Landing Length (in)	N/A	N/A	DWS Provided?	N/A
	N/A	Landing Width (in)	N/A	N/A	DWS Contrast?	N/A
	N/A	Landing Slope (%)	N/A	N/A	DWS Length (in)	N/A
	N/A	Landing X Slope (%)	N/A	N/A	DWS Full Width?	N/A
	N/A	Landing Curb? (Y/N)	N/A	N/A	DWS Offset (in)	N/A
	N/A	Shared Landing?	N/A			
	N/A	Gutter Ponding?	N/A	N/A	Gutter Slope (%)	N/A
	N/A	Gutter Lip Ht (in)	N/A	N/A	Gutter X Slope (%)	N/A
	N/A	Painted X Walk1?	No	N/A	Painted X Walk2?	N/A
		X Walk 1 Direction	To N		X Walk 2 Direction	N/A
		X Walk 1 Width (in)	N/A		X Walk 2 Width (in)	N/A
		X Walk 1 Slope (%)	0.8		X Walk 2 Slope (%)	N/A

X Walk 1 X Slope (%)	2.3		X Walk 2 X Slope (%)	N/A
	N/A	Ramp inside XWalk1?	N/A	N/A	Ramp inside XWalk2?	N/A
		Road Slope (%)	2.3		Clear Space?	N/A
		Road X Slope (%)	0.8	N/A	Clear Space to XWalk (in)	N/A
	N/A	Any Obstructions?	N/A	N/A	Storm Grate/Utility Hazard?	N/A
		Obstruction Type			Storm Grate/Utility Type	
			N/A			N/A
				Yes	Surface Condition? (G/P)	Good
1				No	Curb Slope (%)	5.8
	1

SOUTH STREAM BV Street 1 Name Stop Condition-Street 1 StopSign Street 2 Name N/A Stop Condition-Street 2 N/A **Remove & Replace Curb Ramp With Two New Directional Ramps or** Equivalent.
