## Access Compliance Report Public Rights-of-Way (Curb Ramps)

Intersection ID: 10026073Main Street: ENDERLY\_RDCross Street: N/ALocation:EADA ID: A4E7BB48A65FRamp Type: PerpInitial Pass/Fail: FailOverall Compliance: NoSeverity Score: 12.5

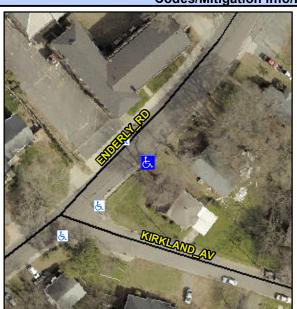
Comp	iance Description	Data	Comp	liance Description	n Data
N/A	Ramp Length (in)	56.0	No	Ramp Slope (%)	9.1
Yes	Ramp Width (in)	49.0	Yes	es Ramp XSlope (%)	
N/A	Flare Type LT	N/A	N/A	Flare Type RT	N/A
N/A	Flare Slope LT (%)	N/A	N/A	Flare Slope RT (%	) N/A
N/A	Flare Traversable LT?	N/A	N/A	Flare Traversable	RT? N/A
N/A	Landing Length (in)	N/A	N/A	DWS Provided?	N/A
N/A	Landing Width (in)	N/A	N/A	DWS Contrast?	N/A
N/A	Landing Slope (%)	N/A	N/A	DWS Length (in)	N/A
N/A	Landing X Slope (%)	N/A	N/A	DWS Full Width?	N/A
N/A	Landing Curb? (Y/N)	N/A	N/A	DWS Offset (in)	N/A
N/A	Shared Landing?	N/A			
N/A	Gutter Ponding?	N/A	N/A	Gutter Slope (%)	N/A
N/A	Gutter Lip Ht (in)	0.5	N/A	Gutter X Slope (%	) <b>N/A</b>
N/A	Painted X Walk1?	No	N/A	Painted X Walk2?	N/A
	X Walk 1 Direction	To N		X Walk 2 Direction	N/A
N/A	X Walk 1 Width (in)	N/A	N/A	X Walk 2 Width (in	) <b>N/A</b>
	X Walk 1 Slope (%)	7.0		X Walk 2 Slope (%	) N/A
	X Walk 1 X Slope (%)	2.0		X Walk 2 X Slope (%)

N/A	Ramp inside XWalk1?	N/A	N/A	Ramp inside XWa	lk2? <b>N/A</b>
	Road Slope (%)	N/A	N/A	N/A Clear Space?	
	Road X Slope (%)	N/A	N/A	Clear Space to XV	Valk (in) N/A
N/A	Any Obstructions?	N/A	N/A	Storm Grate/Utility	Hazard? N/A
	Obstruction Type		Storm Grate/Utility Type		<sup>,</sup> Туре
		N/A			N/A
			Yes	Surface Condition	? (G/P) <b>Good</b>

Possible Solutions:						
Remove & Replace Entire Ramp.						
Surveyor Notes:						
N/A						
PROW/ADA:						
R304.2.2						
R304.2.2
