Access Compliance Report

Public Rights-of-Way

(Curb Ramps)

Intersection ID: 50589	Main Street: BENDING_BRANCH_RD	Cross Street: GREEN_GRASS_RD	Location: E
ADA ID: A4F49628A1B4	Ramp Type: Perp	Initial Pass/Fail: Fail	Overall Compliance: No
Severity Score: 21.25			
Codes/Mitigation Info/Possible Solution		Field Measurements/Component Compliance

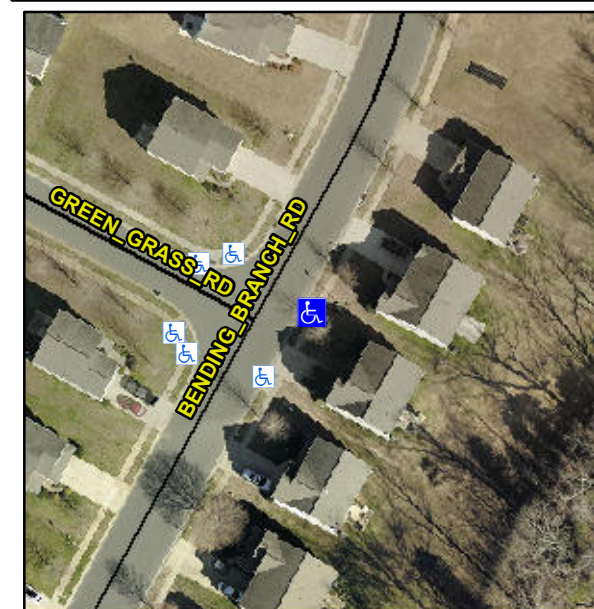
Not Found, R304.5.1, R304.2.2

Compliance	Description	Data	Compliance	Description	Data
N/A	Ramp Length (in)	46.5	No	Ramp Slope (%)	9.0
No	Ramp Width (in)	47.5	Yes	Ramp XSlope (%)	0.5
N/A	Flare Type LT	N/A	N/A	Flare Type RT	N/A
N/A	Flare Slope LT (%)	N/A	N/A	Flare Slope RT (%)	N/A
N/A	Flare Traversable LT?	N/A	N/A	Flare Traversable RT?	N/A
N/A	Landing Length (in)	N/A	N/A	DWS Provided?	N/A
N/A	Landing Width (in)	N/A	N/A	DWS Contrast?	N/A
N/A	Landing Slope (%)	N/A	N/A	DWS Length (in)	N/A
N/A	Landing X Slope (%)	N/A	N/A	DWS Full Width?	N/A
N/A	Landing Curb? (Y/N)	N/A	N/A	DWS Offset (in)	N/A
N/A	Shared Landing?	N/A			
N/A	Gutter Ponding?	Yes	N/A	Gutter Slope (%)	N/A
N/A	Gutter Lip Ht (in)	N/A	N/A	Gutter X Slope (%)	N/A
N/A	Painted X Walk1?	No	N/A	Painted X Walk2?	N/A
	X Walk 1 Direction	To NW		X Walk 2 Direction	N/A
N/A	X Walk 1 Width (in)	N/A	N/A	X Walk 2 Width (in)	N/A
	X Walk 1 Slope (%)	0.3		X Walk 2 Slope (%)	N/A
	X Walk 1 X Slope (%)	0.5		X Walk 2 X Slope (%)	N/A

N/A	Ramp inside XWalk1?	N/A	N/A	Ramp inside XWalk2?	N/A
	Road Slope (%)	N/A	N/A	Clear Space?	N/A
	Road X Slope (%)	N/A	N/A	Clear Space to XWalk (in)	N/A
N/A	Any Obstructions?	N/A	N/A	Storm Grate/Utility Hazard?	N/A
	Obstruction Type			Storm Grate/Utility Type	
		N/A			N/A
			Yes	Surface Condition? (G/P)	Good

Possible Solutions:

Remove & Replace Entire Ramp.
