# Access Compliance Report

## Public Rights-of-Way

### (Curb Ramps)

| Intersection ID: 46346 | Main Street: MEADOW_KNOLL_DR | Cross Street: MINT_THISTLE_CT | Location: SE |

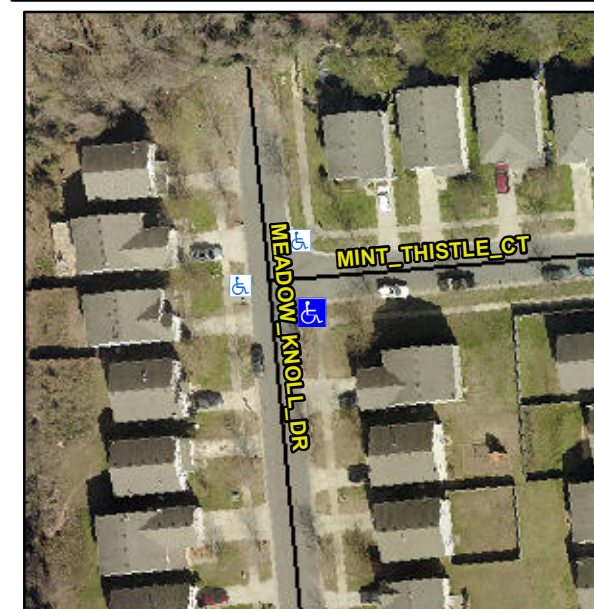
| ADA ID: A4F9078FEE59 | Ramp Type: PerpDiag | Initial Pass/Fail: Pass | Overall Compliance: No |
| Severity Score: 0.25 | | | |

**Not Found, R304.5.3, R304.2.1, R304.2.2-Perp, R304.3.2-Para, R305.2**

| Compliance | Description | Data | Compliance | Description | Data |
|---|---|---|---|---|---|
| Yes | Ramp Width (in) | 48.0 | No | Ramp XSlope (%) | 3.2 |
| No | Landing Width (in) | 45.0 | Yes | DWS Contrast? | Yes |
| No | Landing Slope (%) | 2.1 | Yes | DWS Length (in) | 24.0 |
| No | Landing X Slope (%) | 3.9 | Yes | DWS Full Width? | Yes |
| N/A | Landing Curb? (Y/N) | No | No | DWS Offset (in) | 3.0 |
| Yes | Gutter Lip Ht (in) | 0.0 | No | Gutter X Slope (%) | 2.4 |

**Remove & Replace Curb Ramp With Two New Directional Ramps or Equivalent. Remove & Replace Gutter.**
