Access Compliance Report

Public Rights-of-Way

(Curb Ramps)

Intersection ID: 25141	Main Street: PINEVILLE-MATTHEWS_RD	Cross Street: RIDGELOCH_PL	Location: SE
ADA ID: A4FEE967EFB9	Ramp Type: Perp	Initial Pass/Fail: Fail	Overall Compliance: No
Severity Score: 13.75			
Codes/Mitigation Info/Possible Solution		Field Measurements/Component Compliance

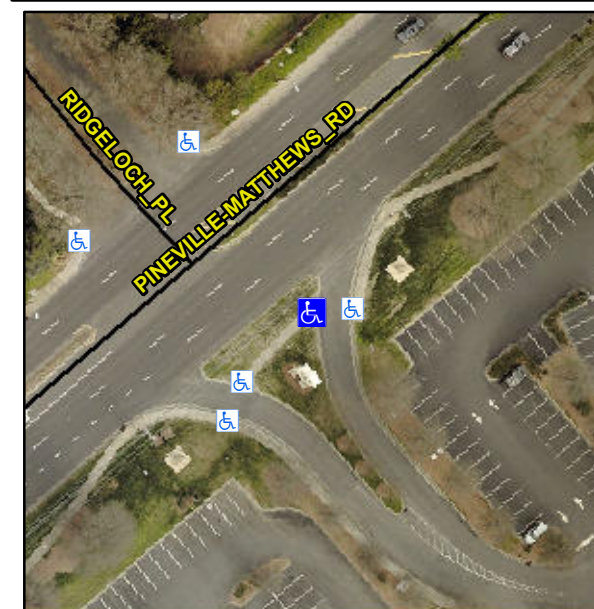
Not Found, R304.2.2, R304.5.3

Compliance	Description	Data	Compliance	Description	Data
N/A	Ramp Length (in)	68.0	No	Ramp Slope (%)	9.8
Yes	Ramp Width (in)	48.0	No	Ramp XSlope (%)	3.4
N/A	Flare Type LT	N/A	N/A	Flare Type RT	N/A
N/A	Flare Slope LT (%)	N/A	N/A	Flare Slope RT (%)	N/A
N/A	Flare Traversable LT?	N/A	N/A	Flare Traversable RT?	N/A
N/A	Landing Length (in)	N/A	N/A	DWS Provided?	N/A
N/A	Landing Width (in)	N/A	N/A	DWS Contrast?	N/A
N/A	Landing Slope (%)	N/A	N/A	DWS Length (in)	N/A
N/A	Landing X Slope (%)	N/A	N/A	DWS Full Width?	N/A
N/A	Landing Curb? (Y/N)	N/A	N/A	DWS Offset (in)	N/A
N/A	Shared Landing?	N/A			
N/A	Gutter Ponding?	N/A	N/A	Gutter Slope (%)	N/A
N/A	Gutter Lip Ht (in)	N/A	N/A	Gutter X Slope (%)	N/A
N/A	Painted X Walk1?	No	N/A	Painted X Walk2?	N/A
	X Walk 1 Direction	To E		X Walk 2 Direction	N/A
N/A	X Walk 1 Width (in)	N/A	N/A	X Walk 2 Width (in)	N/A
	X Walk 1 Slope (%)	0.1		X Walk 2 Slope (%)	N/A
	X Walk 1 X Slope (%)	4.6		X Walk 2 X Slope (%)	N/A

N/A	Ramp inside XWalk1?	N/A	N/A	Ramp inside XWalk2?	N/A
	Road Slope (%)	N/A	N/A	Clear Space?	N/A
	Road X Slope (%)	N/A	N/A	Clear Space to XWalk (in)	N/A
N/A	Any Obstructions?	N/A	N/A	Storm Grate/Utility Hazard?	N/A
	Obstruction Type			Storm Grate/Utility Type	
		N/A			N/A
			Yes	Surface Condition? (G/P)	Good

Remove & Replace Entire Ramp.
