Access Compliance Report

Public Rights-of-Way

(Curb Ramps)

Intersection ID: 16141	Main Street: N_WENDOVER_RD	Cross Street: LATROBE_DR	Location: NW
ADA ID: A5004ACA78FF	Ramp Type: MedianPerp	Initial Pass/Fail: Fail	Overall Compliance: No
Severity Score: 22.5			
Codes/Mitigation Info/Possible Solution		Field Measurements/Component Compliance

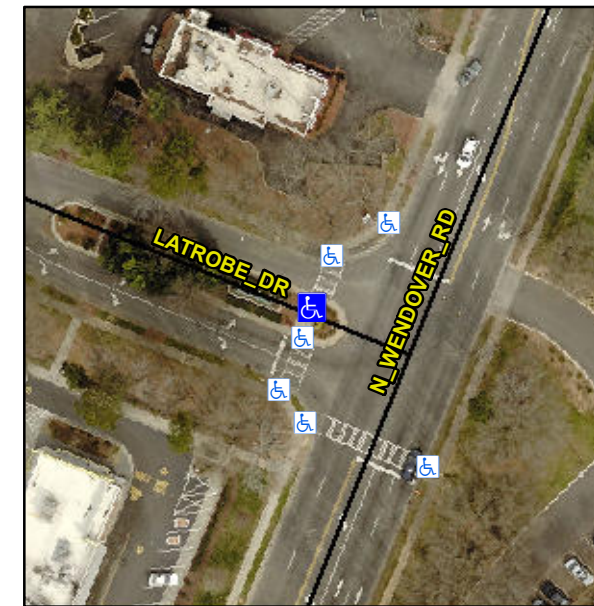
Not Found, R304.5.1, R304.2.2, R304.5.3

Compliance	Description	Data	Compliance	Description	Data
N/A	Ramp Length (in)	72.0	No	Ramp Slope (%)	10.7
No	Ramp Width (in)	45.0	No	Ramp XSlope (%)	3.5
N/A	Flare Type LT	N/A	N/A	Flare Type RT	N/A
N/A	Flare Slope LT (%)	N/A	N/A	Flare Slope RT (%)	N/A
N/A	Flare Traversable LT?	N/A	N/A	Flare Traversable RT?	N/A
N/A	Landing Length (in)	N/A	N/A	DWS Provided?	N/A
N/A	Landing Width (in)	N/A	N/A	DWS Contrast?	N/A
N/A	Landing Slope (%)	N/A	N/A	DWS Length (in)	N/A
N/A	Landing X Slope (%)	N/A	N/A	DWS Full Width?	N/A
N/A	Landing Curb? (Y/N)	N/A	N/A	DWS Offset (in)	N/A
N/A	Shared Landing?	N/A			
N/A	Gutter Ponding?	N/A	N/A	Gutter Slope (%)	N/A
N/A	Gutter Lip Ht (in)	N/A	N/A	Gutter X Slope (%)	N/A
N/A	Painted X Walk1?	Yes	N/A	Painted X Walk2?	N/A
	X Walk 1 Direction	To NE		X Walk 2 Direction	N/A
N/A	X Walk 1 Width (in)	110.0	N/A	X Walk 2 Width (in)	N/A
	X Walk 1 Slope (%)	7.3		X Walk 2 Slope (%)	N/A
	X Walk 1 X Slope (%)	2.6		X Walk 2 X Slope (%)	N/A

N/A	Ramp inside XWalk1?	Yes	N/A	Ramp inside XWalk2?	N/A
	Road Slope (%)	N/A	N/A	Clear Space?	N/A
	Road X Slope (%)	N/A	N/A	Clear Space to XWalk (in)	N/A
N/A	Any Obstructions?	N/A	N/A	Storm Grate/Utility Hazard?	N/A
	Obstruction Type			Storm Grate/Utility Type	
		N/A			N/A
			Yes	Surface Condition? (G/P)	Good

Possible Solutions:

Remove & Replace Entire Ramp.
