Access Compliance Report

Public Rights-of-Way

(Curb Ramps)

Intersection ID: 18269	Main Street: MCLAUGHLIN_DR	Cross Street: PINAFORE_DR	Location: SW
ADA ID: A5091A57EEAE	Ramp Type: PerpDiag	Initial Pass/Fail: Fail	Overall Compliance: No
		Severity Score: 25

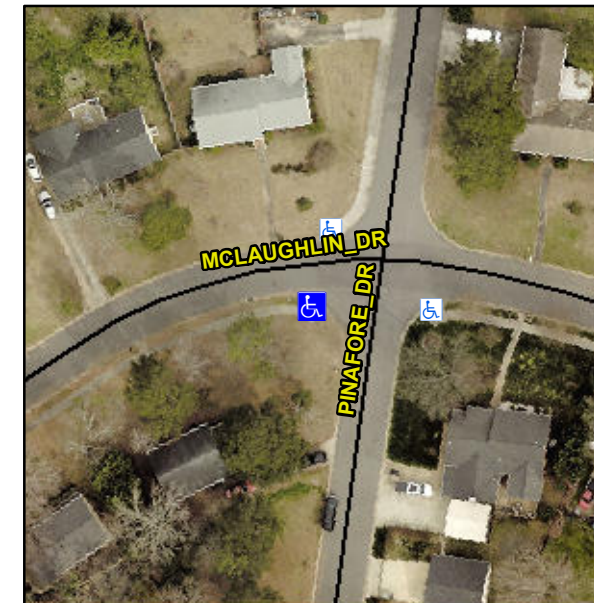
Not Found, R304.5.3

Compliance	Description	Data	Compliance	Description	Data
N/A	Ramp Length (in)	48.0	Yes	Ramp Slope (%)	5.9
Yes	Ramp Width (in)	48.0	No	Ramp XSlope (%)	7.5
N/A	Flare Type LT	N/A	N/A	Flare Type RT	N/A
N/A	Flare Slope LT (%)	N/A	N/A	Flare Slope RT (%)	N/A
N/A	Flare Traversable LT?	N/A	N/A	Flare Traversable RT?	N/A
N/A	Landing Length (in)	N/A	N/A	DWS Provided?	N/A
N/A	Landing Width (in)	N/A	N/A	DWS Contrast?	N/A
N/A	Landing Slope (%)	N/A	N/A	DWS Length (in)	N/A
N/A	Landing X Slope (%)	N/A	N/A	DWS Full Width?	N/A
N/A	Landing Curb? (Y/N)	N/A	N/A	DWS Offset (in)	N/A
N/A	Shared Landing?	N/A			
N/A	Gutter Ponding?	N/A	N/A	Gutter Slope (%)	N/A
N/A	Gutter Lip Ht (in)	N/A	N/A	Gutter X Slope (%)	N/A
N/A	Painted X Walk1?	No	N/A	Painted X Walk2?	No
	X Walk 1 Direction	To E		X Walk 2 Direction	To NE
N/A	X Walk 1 Width (in)	N/A	N/A	X Walk 2 Width (in)	N/A
	X Walk 1 Slope (%)	2.7		X Walk 2 Slope (%)	5.6
	X Walk 1 X Slope (%)	5.8		X Walk 2 X Slope (%)	2.0

N/A	Ramp inside XWalk1?	N/A	N/A	Ramp inside XWalk2?	N/A
	Road Slope (%)	7.2	N/A	Clear Space?	N/A
	Road X Slope (%)	5.9	N/A	Clear Space to XWalk (in)	N/A
N/A	Any Obstructions?	N/A	N/A	Storm Grate/Utility Hazard?	N/A
	Obstruction Type			Storm Grate/Utility Type	
		N/A			N/A
			Yes	Surface Condition? (G/P)	Good

Remove & Replace Curb Ramp With Two New Directional Ramps or Equivalent.

Total Cost: \$ 3200.00
