# Access Compliance Report

### (Curb Ramps)

| Intersection ID: 19682 | Main Street: FLODDEN_FIELD_CT | Cross Street: YORKDALE_DR | Location: SW |
| ADA ID: A509DAB1B238 | Ramp Type: BlendTrans2 | Initial Pass/Fail: Pass | Overall Compliance: No |

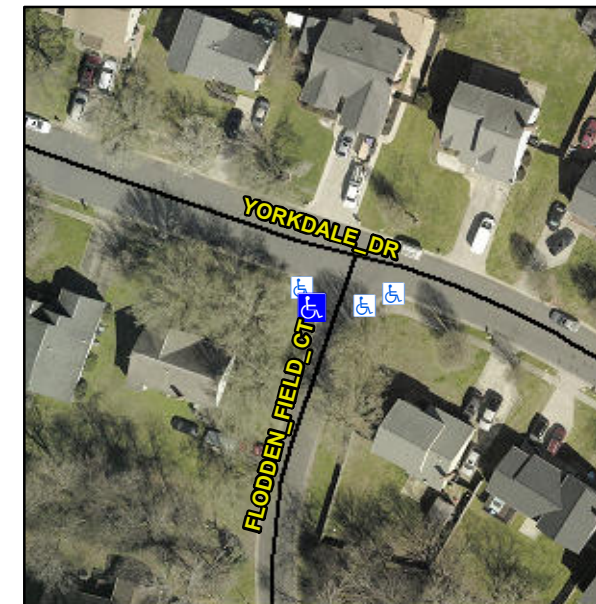
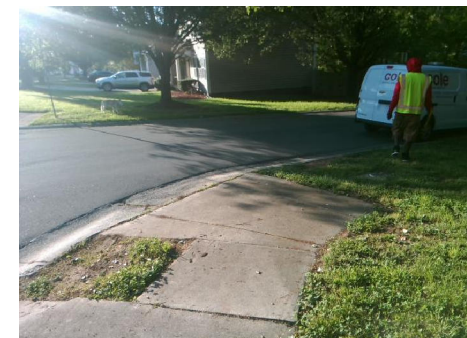
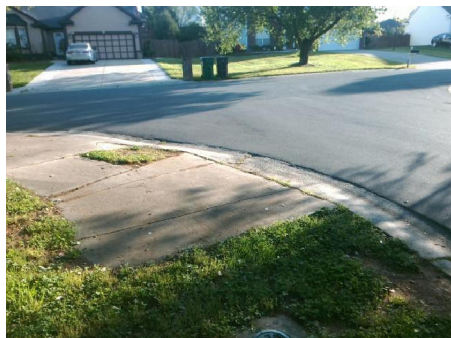
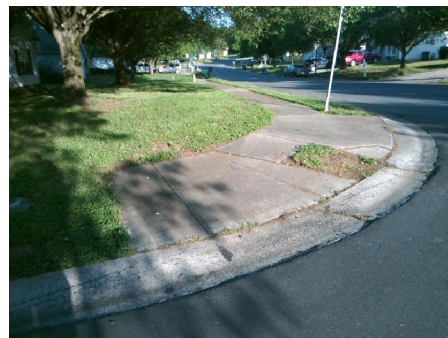
| Severity Score: 17.75 | | | |

| Compliance | Description | Data | Compliance | Description | Data |
|---|---|---|---|---|---|
| N/A | Ramp Length (in) | 92.0 | Yes | BlendTrans Slope (%) | 4.1 |
| Yes | Ramp Width (in) | 56.0 | No | BlendTrans XSlope (%) | 4.9 |
| N/A | Landing Length (in) | N/A | No | DWS Provided? | No |
| No | Gutter Lip Ht (in) | 0.5 | No | Gutter X Slope (%) | 3.2 |

**Remove & Replace Curb Ramp With Two New Directional Ramps or Equivalent. Remove & Replace Gutter.**

**R304.5.3, R305, R302.7.2**
