Access Compliance Report

Public Rights-of-Way

(Curb Ramps)

Intersection ID: 4727	Main Street: BRIGGS_DR	Cross Street: LOWEN_RD	Location: SE
ADA ID: A513EB4B909A	Ramp Type: PerpDiag	Initial Pass/Fail: Fail	Overall Compliance: No
			Severity Score: 46.25

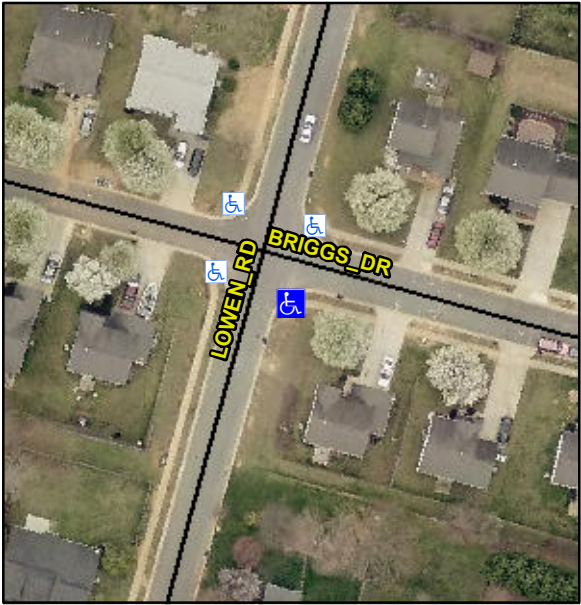
Possible Solutions:		Compliance	Description	Data
	Remove & Replace Curb Ramp With Two New Directional Ramps or Equivalent.		No	Ramp Length (in)	47.0
			No	Ramp Width (in)	37.0
			N/A	Flare Type LT	N/A
			N/A	Flare Slope LT (%)	N/A
			N/A	Flare Traversable LT?	N/A
			N/A	Landing Length (in)	N/A
			N/A	Landing Width (in)	N/A
			N/A	Landing Slope (%)	N/A
			N/A	Landing X Slope (%)	N/A
<p>Surveyor Notes:</p> <p>N/A</p> <p>PROW/ADA:</p> <p>Not Found, R304.5.1, R304.2.2, R304.5.3</p>			N/A	Flare Type RT	N/A
			N/A	Flare Slope RT (%)	N/A
			N/A	Flare Traversable RT?	N/A
			N/A	DWS Provided?	N/A
			N/A	DWS Contrast?	N/A
			N/A	DWS Length (in)	N/A
			N/A	DWS Full Width?	N/A
			N/A	DWS Offset (in)	N/A
			N/A	Gutter Ponding?	N/A
			N/A	Gutter Lip Ht (in)	N/A
			No	Painted X Walk1?	No
				X Walk 1 Direction	To NE
			N/A	X Walk 1 Width (in)	N/A

X Walk 1 Slope (%)	8.7
				X Walk 1 X Slope (%)	4.2
			N/A	Ramp inside XWalk1?	N/A
				Road Slope (%)	6.9
				Road X Slope (%)	6.7
			N/A	Any Obstructions?	N/A
				Obstruction Type	
Total Cost:					
		\$ 3200.00			
			N/A	Clear Space?	N/A
			N/A	Clear Space to XWalk (in)	N/A
			N/A	Storm Grate/Utility Hazard?	N/A
				Storm Grate/Utility Type	
			N/A		N/A
			Yes	Surface Condition? (G/P)	Good
