# Access Compliance Report

## Public Rights-of-Way

### (Curb Ramps)

Intersection ID: 7249	Main Street: HIDDEN_FOREST_DR	Cross Street: TOM_HUNTER_RD	Location: SE
ADA ID: A52FD8526F99	Ramp Type: ParaDiag	Initial Pass/Fail: Fail	Overall Compliance: No
Severity Score: 33.75			
Codes/Mitigation Info/Possible Solution		Field Measurements/Component Compliance

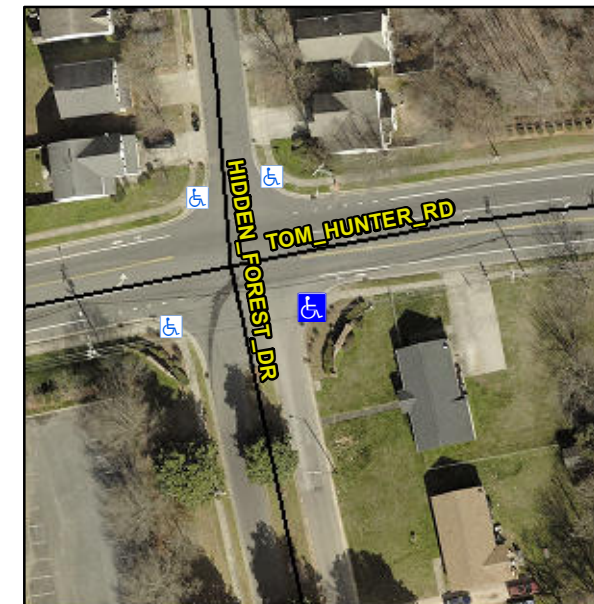
**NO RT SW, RT RP < 5%**

**R304.5.1, R304.3.2, R304.5.3**

Compliance	Description	Data	Compliance	Description	Data
N/A	Ramp Length LT (in)	61.5	N/A	Ramp Length RT (in)	75.0
No	Ramp Width LT (in)	47.5	Yes	Ramp Width RT (in)	61.0
No	Ramp Slope LT (%)	8.9	Yes	Ramp Slope RT (%)	1.6
No	Ramp XSlope LT (%)	6.1	No	Ramp XSlope RT (%)	6.6
N/A	Landing Length (in)	N/A	N/A	DWS Provided?	N/A
N/A	Landing Width (in)	N/A	N/A	DWS Contrast?	N/A
N/A	Landing Slope (%)	N/A	N/A	DWS Length (in)	N/A
N/A	Landing X Slope (%)	N/A	N/A	DWS Full Width?	N/A
N/A	Landing Curb? (Y/N)	N/A	N/A	DWS Offset (in)	N/A
N/A	Shared Landing?	N/A			
N/A	Gutter Ponding?	N/A	N/A	Gutter Slope (%)	N/A
N/A	Gutter Lip Ht (in)	1.0	N/A	Gutter X Slope (%)	N/A
N/A	Painted X Walk1?	No	N/A	Painted X Walk2?	No
	X Walk 1 Direction	To N		X Walk 2 Direction	To W
N/A	X Walk 1 Width (in)	N/A	N/A	X Walk 2 Width (in)	N/A
	X Walk 1 Slope (%)	2.2		X Walk 2 Slope (%)	0.8
	X Walk 1 X Slope (%)	2.9		X Walk 2 X Slope (%)	3.1
N/A	Ramp inside XWalk1?	N/A	N/A	Ramp inside XWalk2?	N/A

Road Slope (%)	4.1	N/A	Clear Space?	N/A
	Road X Slope (%)	3.4	N/A	Clear Space to XWalk (in)	N/A
N/A	Any Obstructions?	N/A	N/A	Storm Grate/Utility Hazard?	N/A
	Obstruction Type			Storm Grate/Utility Type	
		N/A			N/A
			Yes	Surface Condition? (G/P)	Good
			N/A	Curb Slope (%)	30.2

**Remove & Replace Curb Ramp With Two New Directional Ramps or Equivalent.**
