# Access Compliance Report

## Public Rights-of-Way

### (Curb Ramps)

Intersection ID: N/A	Main Street: MONROE_RD	Cross Street: BUFORD_AV	Location: SW
ADA ID: A530B2808512	Ramp Type: Directional2	Initial Pass/Fail: Fail	Overall Compliance: No
		Severity Score: 12.5

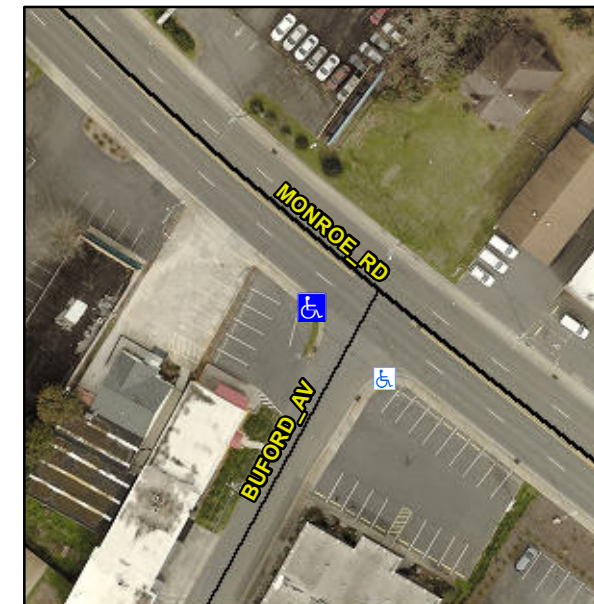
Compliance	Description	Data	Compliance	Description	Data
N/A	Ramp Length (in)	49.0	N/A	Grade Break?	N/A
Yes	Ramp Width (in)	49.0	N/A	Grade Break Slope (%)	0.0
No	Ramp Slope (%)	11.6	N/A	Grade Break XSlope (%)	0.0
Yes	Ramp XSlope (%)	1.5			
N/A	Flare Type LT	N/A	N/A	Flare Type RT	N/A
N/A	Flare Slope LT (%)	N/A	N/A	Flare Slope RT (%)	0.0
N/A	Flare Traversable LT?	N/A	N/A	Flare Traversable RT?	N/A
N/A	Landing Length (in)	0.0	N/A	DWS Provided?	N/A
N/A	Landing Width (in)	0.0	N/A	DWS Contrast?	N/A
N/A	Landing Slope (%)	0.0	N/A	DWS Length (in)	N/A
N/A	Landing X Slope (%)	0.0	N/A	DWS Full Width?	N/A
N/A	Landing Curb? (Y/N)	N/A	N/A	DWS Offset LT (in)	N/A
N/A	Shared Landing?	N/A	N/A	DWS Offset RT (in)	N/A
N/A	Gutter Ponding?	0.0	N/A	Gutter Slope (%)	N/A
N/A	Gutter Lip Ht (in)	0.0	N/A	Gutter X Slope (%)	N/A
N/A	Painted X Walk1?	No		Road Slope (%)	3.2
	X Walk 1 Direction	To SE		Road X Slope (%)	1.9
	X Walk 1 Width (in)	N/A		Clear Space?	N/A

X Walk 1 Slope (%)	3.2	N/A	Clear Space to XWalk (in)	N/A
	X Walk 1 X Slope (%)	1.9	N/A	Storm Grate/Utility Hazard?	N/A
N/A	Ramp inside XWalk1?	N/A		Storm Grate/Utility Type	
N/A	Any Obstructions?	N/A			N/A
	Obstruction Type		Yes	Surface Condition? (G/P)	Good
			N/A	Curb Slope (%)	3.4

Possible Solutions:

**Remove & Replace Entire Ramp.**

Total Cost: \$ 1800.00
