Access Compliance Report

Public Rights-of-Way

(Curb Ramps)

Intersection ID: 5567	Main Street: JOHN_KIRK_DR	Cross Street: UNIVERSITY_TERRACE_DR	Location: NE
ADA ID: A5325588DDD6	Ramp Type: Directional1	Initial Pass/Fail: Fail	Overall Compliance: No
Codes/Mitigation Info/Possible Solution		Field Measurements/Component Compliance	
Severity Score: 1.25

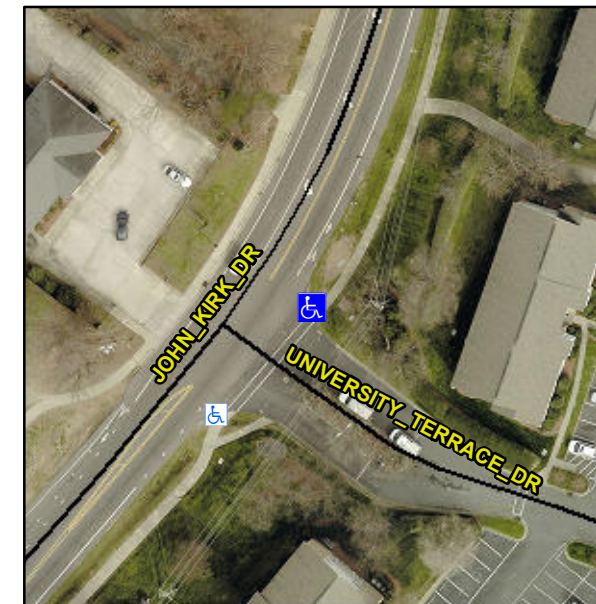
R304.5.3

Compliance	Description	Data	Compliance	Description	Data
N/A	Ramp Length (in)	58.0	N/A	Grade Break?	N/A
Yes	Ramp Width (in)	59.0	N/A	Grade Break Slope (%)	0.0
Yes	Ramp Slope (%)	2.0	N/A	Grade Break XSlope (%)	0.0
No	Ramp XSlope (%)	2.8			
N/A	Flare Type LT	N/A	N/A	Flare Type RT	N/A
N/A	Flare Slope LT (%)	N/A	N/A	Flare Slope RT (%)	0.0
N/A	Flare Traversable LT?	N/A	N/A	Flare Traversable RT?	N/A
N/A	Landing Length (in)	0.0	N/A	DWS Provided?	N/A
N/A	Landing Width (in)	0.0	N/A	DWS Contrast?	N/A
N/A	Landing Slope (%)	0.0	N/A	DWS Length (in)	N/A
N/A	Landing X Slope (%)	0.0	N/A	DWS Full Width?	N/A
N/A	Landing Curb? (Y/N)	N/A	N/A	DWS Offset LT (in)	N/A
N/A	Shared Landing?	N/A	N/A	DWS Offset RT (in)	N/A
N/A	Gutter Ponding?	0.0	N/A	Gutter Slope (%)	N/A
N/A	Gutter Lip Ht (in)	0.0	N/A	Gutter X Slope (%)	N/A
N/A	Painted X Walk1?	No		Road Slope (%)	0.1
	X Walk 1 Direction	To SW		Road X Slope (%)	2.4
	X Walk 1 Width (in)	N/A		Clear Space?	N/A

X Walk 1 Slope (%)	0.1	N/A	Clear Space to XWalk (in)	N/A
	X Walk 1 X Slope (%)	2.4	N/A	Storm Grate/Utility Hazard?	N/A
N/A	Ramp inside XWalk1?	N/A		Storm Grate/Utility Type	
N/A	Any Obstructions?	N/A			N/A
	Obstruction Type		Yes	Surface Condition? (G/P)	Good
			N/A	Curb Slope (%)	11.0

Remove & Replace Entire Ramp.
