Access Compliance Report

Public Rights-of-Way

(Curb Ramps)

Intersection ID: 11054	Main Street: DOWNS_AV	Cross Street: NEWELL_AV	Location: S
ADA ID: A5325CA23680	Ramp Type: Perp	Initial Pass/Fail: Fail	Overall Compliance: No
Severity Score: 33.75			
Codes/Mitigation Info/Possible Solution		Field Measurements/Component Compliance

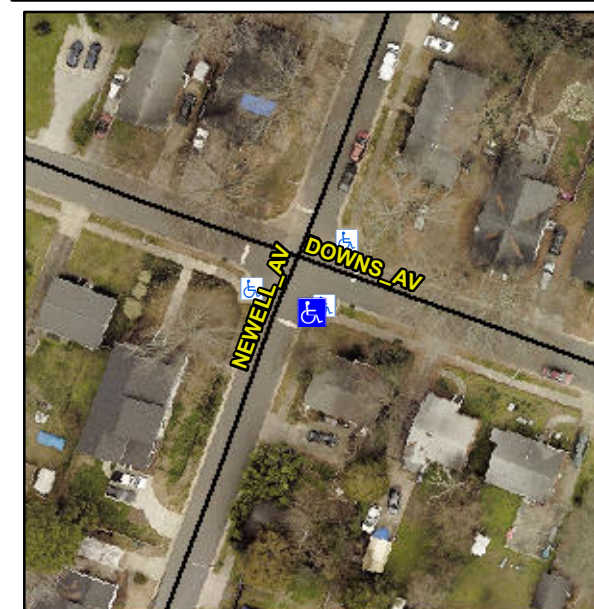
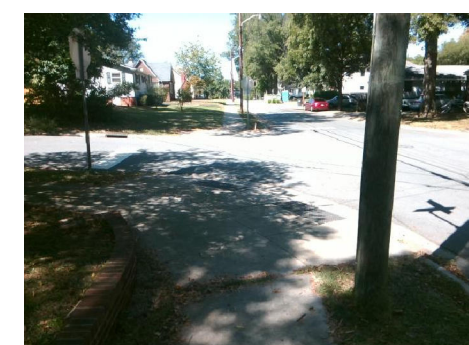
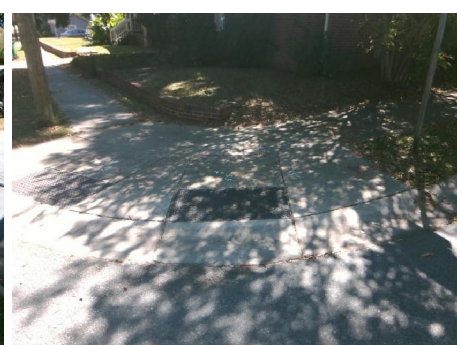
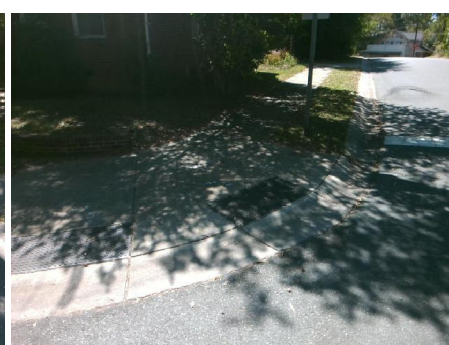
Not Found, R304.5.1, R304.5.3

Compliance	Description	Data	Compliance	Description	Data
N/A	Ramp Length (in)	65.0	Yes	Ramp Slope (%)	5.5
No	Ramp Width (in)	47.5	No	Ramp XSlope (%)	7.6
N/A	Flare Type LT	N/A	N/A	Flare Type RT	N/A
N/A	Flare Slope LT (%)	N/A	N/A	Flare Slope RT (%)	N/A
N/A	Flare Traversable LT?	N/A	N/A	Flare Traversable RT?	N/A
N/A	Landing Length (in)	N/A	N/A	DWS Provided?	N/A
N/A	Landing Width (in)	N/A	N/A	DWS Contrast?	N/A
N/A	Landing Slope (%)	N/A	N/A	DWS Length (in)	N/A
N/A	Landing X Slope (%)	N/A	N/A	DWS Full Width?	N/A
N/A	Landing Curb? (Y/N)	N/A	N/A	DWS Offset (in)	N/A
N/A	Shared Landing?	N/A			
N/A	Gutter Ponding?	N/A	N/A	Gutter Slope (%)	N/A
N/A	Gutter Lip Ht (in)	N/A	N/A	Gutter X Slope (%)	N/A
N/A	Painted X Walk1?	No	N/A	Painted X Walk2?	N/A
	X Walk 1 Direction	To NW		X Walk 2 Direction	N/A
N/A	X Walk 1 Width (in)	N/A	N/A	X Walk 2 Width (in)	N/A
	X Walk 1 Slope (%)	3.3		X Walk 2 Slope (%)	N/A
	X Walk 1 X Slope (%)	3.9		X Walk 2 X Slope (%)	N/A

N/A	Ramp inside XWalk1?	N/A	N/A	Ramp inside XWalk2?	N/A
	Road Slope (%)	N/A	N/A	Clear Space?	N/A
	Road X Slope (%)	N/A	N/A	Clear Space to XWalk (in)	N/A
N/A	Any Obstructions?	N/A	N/A	Storm Grate/Utility Hazard?	N/A
	Obstruction Type			Storm Grate/Utility Type	
		N/A			N/A
			Yes	Surface Condition? (G/P)	Good

Remove & Replace Entire Ramp.
