Access Compliance Report

Public Rights-of-Way

(Curb Ramps)

Intersection ID: 12455	Main Street: W_3RD_ST	Cross Street: S_TRYON_ST	Location: W
ADA ID: A532A68F2586	Ramp Type: Perp	Initial Pass/Fail: Fail	Overall Compliance: No
Severity Score: 12.5			
Codes/Mitigation Info/Possible Solution		Field Measurements/Component Compliance

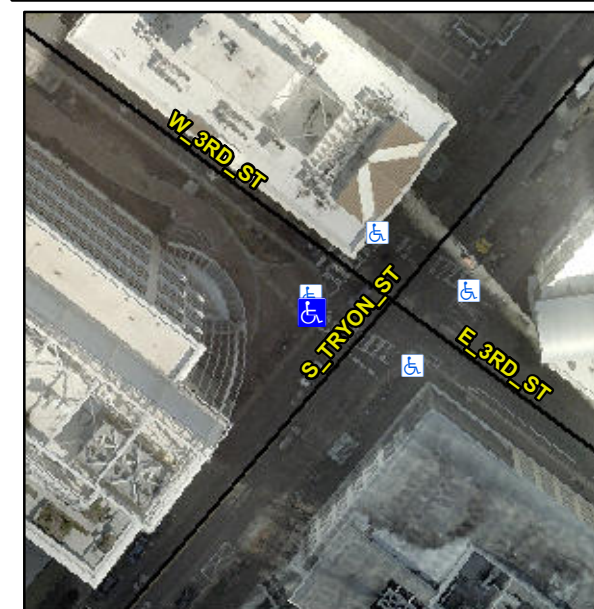
Compliance	Description	Data	Compliance	Description	Data
N/A	Ramp Length (in)	24.0	Yes	Ramp Slope (%)	7.3
Yes	Ramp Width (in)	58.0	No	Ramp XSlope (%)	6.9
N/A	Flare Type LT	N/A	N/A	Flare Type RT	N/A
N/A	Flare Slope LT (%)	N/A	N/A	Flare Slope RT (%)	N/A
N/A	Flare Traversable LT?	N/A	N/A	Flare Traversable RT?	N/A
N/A	Landing Length (in)	N/A	N/A	DWS Provided?	N/A
N/A	Landing Width (in)	N/A	N/A	DWS Contrast?	N/A
N/A	Landing Slope (%)	N/A	N/A	DWS Length (in)	N/A
N/A	Landing X Slope (%)	N/A	N/A	DWS Full Width?	N/A
N/A	Landing Curb? (Y/N)	N/A	N/A	DWS Offset (in)	N/A
N/A	Shared Landing?	N/A			
N/A	Gutter Ponding?	N/A	N/A	Gutter Slope (%)	N/A
N/A	Gutter Lip Ht (in)	N/A	N/A	Gutter X Slope (%)	N/A
N/A	Painted X Walk1?	Yes	N/A	Painted X Walk2?	N/A
	X Walk 1 Direction	To SE		X Walk 2 Direction	N/A
N/A	X Walk 1 Width (in)	108.0	N/A	X Walk 2 Width (in)	N/A
	X Walk 1 Slope (%)	0.9		X Walk 2 Slope (%)	N/A
	X Walk 1 X Slope (%)	0.3		X Walk 2 X Slope (%)	N/A

N/A	Ramp inside XWalk1?	Yes	N/A	Ramp inside XWalk2?	N/A
	Road Slope (%)	N/A	N/A	Clear Space?	N/A
	Road X Slope (%)	N/A	N/A	Clear Space to XWalk (in)	N/A
N/A	Any Obstructions?	N/A	N/A	Storm Grate/Utility Hazard?	N/A
	Obstruction Type			Storm Grate/Utility Type	
		N/A			N/A
		Yes		Surface Condition? (G/P)	Good

Possible Solutions:

Remove & Replace Entire Ramp.

R304.5.3
