# Access Compliance Report

## Public Rights-of-Way

### (Curb Ramps)

Intersection ID: 48713	Main Street: ROLLING_CREEK_CT	Cross Street: KILCULLEN_DR	Location:	N
ADA ID: A536FA58D4AF	Ramp Type: PerpDiag	Initial Pass/Fail: Fail	Overall Compliance: No	Severity Score: 22.5
Codes/Mitigation Info/Possible Solution		Field Measurements/Component Compliance

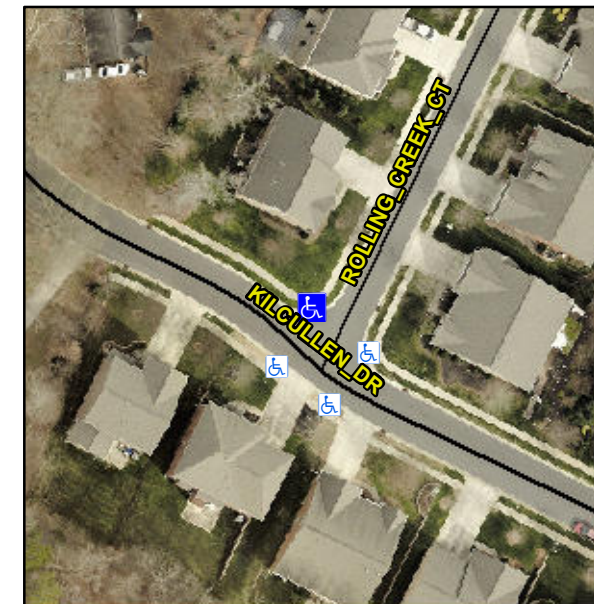
**R304.5.1, R304.2.2, R304.5.3**

Compliance	Description	Data	Compliance	Description	Data
N/A	Ramp Length (in)	48.0	No	Ramp Slope (%)	8.8
No	Ramp Width (in)	46.0	No	Ramp XSlope (%)	4.4
N/A	Flare Type LT	N/A	N/A	Flare Type RT	N/A
N/A	Flare Slope LT (%)	N/A	N/A	Flare Slope RT (%)	N/A
N/A	Flare Traversable LT?	N/A	N/A	Flare Traversable RT?	N/A
N/A	Landing Length (in)	N/A	N/A	DWS Provided?	N/A
N/A	Landing Width (in)	N/A	N/A	DWS Contrast?	N/A
N/A	Landing Slope (%)	N/A	N/A	DWS Length (in)	N/A
N/A	Landing X Slope (%)	N/A	N/A	DWS Full Width?	N/A
N/A	Landing Curb? (Y/N)	N/A	N/A	DWS Offset (in)	N/A
N/A	Shared Landing?	N/A			
N/A	Gutter Ponding?	N/A	N/A	Gutter Slope (%)	N/A
N/A	Gutter Lip Ht (in)	N/A	N/A	Gutter X Slope (%)	N/A
N/A	Painted X Walk1?	No	N/A	Painted X Walk2?	No
	X Walk 1 Direction	To SW		X Walk 2 Direction	To SE
N/A	X Walk 1 Width (in)	N/A	N/A	X Walk 2 Width (in)	N/A
	X Walk 1 Slope (%)	0.3		X Walk 2 Slope (%)	4.5
	X Walk 1 X Slope (%)	5.5		X Walk 2 X Slope (%)	0.8

N/A	Ramp inside XWalk1?	N/A	N/A	Ramp inside XWalk2?	N/A
	Road Slope (%)	5.6	N/A	Clear Space?	N/A
	Road X Slope (%)	6.6	N/A	Clear Space to XWalk (in)	N/A
N/A	Any Obstructions?	N/A	N/A	Storm Grate/Utility Hazard?	N/A
	Obstruction Type			Storm Grate/Utility Type	
		N/A			N/A
			Yes	Surface Condition? (G/P)	Good

**Remove & Replace Curb Ramp With Two New Directional Ramps or Equivalent.**
