## **Access Compliance Report Public Rights-of-Way** (Curb Ramps)

Intersection ID: 14409 Main Street: LABURNUM AV **Cross Street: LORNA ST** Location:

Initial Pass/Fail: Fail **Overall Compliance: No** ADA ID: A53A66980400 Ramp Type: Perp Severity Score: 21.25

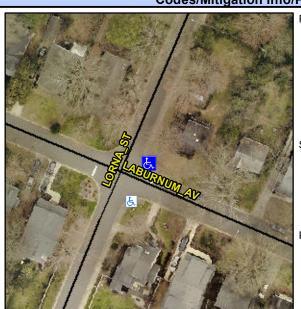
**LABURNUM AV** Street 1 Name Stop Condition-Street 2 StopSign N/A Street 2 Name Stop Condition-Street 1 N/A Possible Solutions: Compliance Description N/A Remove & Replace Entire Ramp. No Surveyor Notes: N/A PROW/ADA: Not Found, R304.5.1, R304.2.2

N/A N/A N/A N/A N/A Total Cost: 1850.00
