# Access Compliance Report

## Public Rights-of-Way

### (Curb Ramps)

Intersection ID: 24079	Main Street: LIVINGSTON_MILL_RD	Cross Street: MOSS_RD	Location: SW
ADA ID: A53C35523CBE	Ramp Type: PerpDiag	Initial Pass/Fail: Pass	Overall Compliance: No
Codes/Mitigation Info/Possible Solution		Field Measurements/Component Compliance

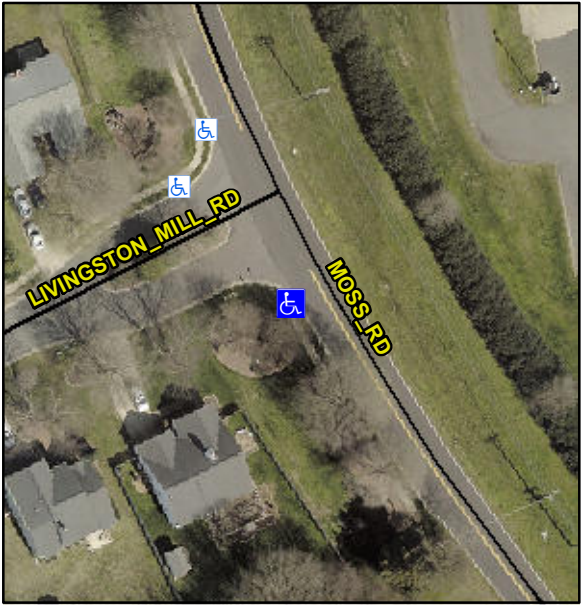
Possible Solutions:						
	Remove & Replace Curb Ramp With Two New Directional Ramps or Equivalent.	N/A	Ramp Length (in)	96.0	Yes	Ramp Slope (%)	6.1
		Yes	Ramp Width (in)	48.0	Yes	Ramp XSlope (%)	0.9
		N/A	Flare Type LT	Sloped	N/A	Flare Type RT	N/A
		N/A	Flare Slope LT (%)	1.7	N/A	Flare Slope RT (%)	2.6
		N/A	Flare Traversable LT?	Yes	N/A	Flare Traversable RT?	No
		No	Landing Length (in)	N/A	Yes	DWS Provided?	Yes
		No	Landing Width (in)	N/A	Yes	DWS Contrast?	Yes
		No	Landing Slope (%)	N/A	Yes	DWS Length (in)	24.0
		No	Landing X Slope (%)	N/A	Yes	DWS Full Width?	Yes
<p>Surveyor Notes:</p> <p>N/A</p> <p>PROW/ADA:</p> <p>R304.2.1, R304.2.2-Perp, R304.3.2-Para, R304.5.3, R305.2</p>		N/A	Landing Curb? (Y/N)	No	No	DWS Offset (in)	6.0
		N/A	Shared Landing?	No			
		Yes	Gutter Ponding?	No	Yes	Gutter Slope (%)	3.0
		Yes	Gutter Lip Ht (in)	0.0	Yes	Gutter X Slope (%)	1.5
		N/A	Painted X Walk1?	No	N/A	Painted X Walk2?	No

X Walk 1 Direction	To NE		X Walk 2 Direction	To NW
		N/A	X Walk 1 Width (in)	N/A	N/A	X Walk 2 Width (in)	N/A
			X Walk 1 Slope (%)	5.9		X Walk 2 Slope (%)	0.6
			X Walk 1 X Slope (%)	1.0		X Walk 2 X Slope (%)	4.6
		N/A	Ramp inside XWalk1?	N/A	N/A	Ramp inside XWalk2?	N/A
<p>Street 1 Name</p> <p>Stop Condition-Street 2</p> <p>Street 2 Name</p> <p>Stop Condition-Street 1</p>			Road Slope (%)	4.0	N/A	Clear Space?	Yes
			Road X Slope (%)	5.7	N/A	Clear Space to XWalk (in)	N/A
		Yes	Any Obstructions?	No	Yes	Storm Grate/Utility Hazard?	No
			Obstruction Type			Storm Grate/Utility Type	
					N/A		N/A
					Yes	Surface Condition? (G/P)	Good
Total Cost:		\$	3200.00
