Access Compliance Report

Public Rights-of-Way (Curb Ramps)

Intersection ID: 14632	Main Street: FARM_POND_LN	Cross Street: MOCK_ROBIN_LN	Location: NE
ADA ID: A53F62474D5A	Ramp Type: Directional1	Initial Pass/Fail: Fail	Overall Compliance: No
		Severity Score: 10

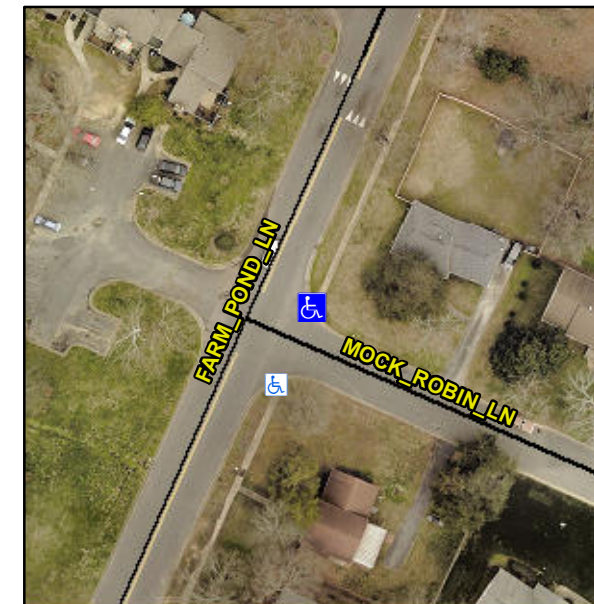
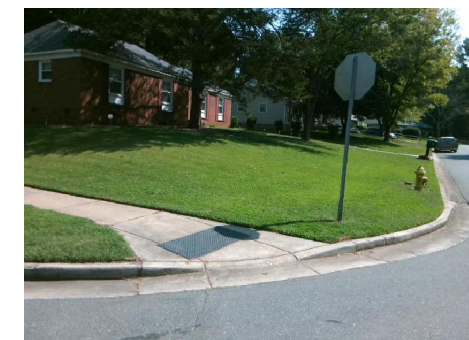
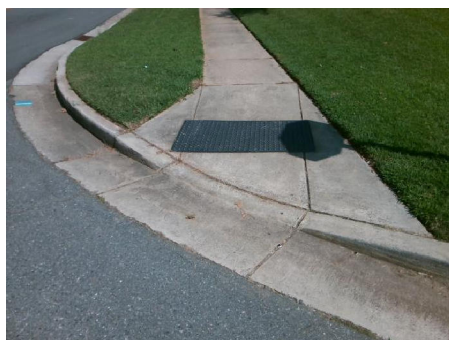
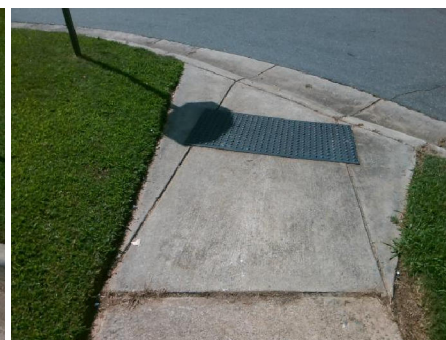
R304.5.1, R304.5.3

Compliance	Description	Data	Compliance	Description	Data
N/A	Ramp Length (in)	73.5	N/A	Grade Break?	N/A
No	Ramp Width (in)	42.0	N/A	Grade Break Slope (%)	0.0
Yes	Ramp Slope (%)	6.3	N/A	Grade Break XSlope (%)	0.0
No	Ramp XSlope (%)	4.5			
N/A	Flare Type LT	N/A	N/A	Flare Type RT	N/A
N/A	Flare Slope LT (%)	N/A	N/A	Flare Slope RT (%)	0.0
N/A	Flare Traversable LT?	N/A	N/A	Flare Traversable RT?	N/A
N/A	Landing Length (in)	0.0	N/A	DWS Provided?	N/A
N/A	Landing Width (in)	0.0	N/A	DWS Contrast?	N/A
N/A	Landing Slope (%)	0.0	N/A	DWS Length (in)	N/A
N/A	Landing X Slope (%)	0.0	N/A	DWS Full Width?	N/A
N/A	Landing Curb? (Y/N)	N/A	N/A	DWS Offset LT (in)	N/A
N/A	Shared Landing?	N/A	N/A	DWS Offset RT (in)	N/A
N/A	Gutter Ponding?	0.0	N/A	Gutter Slope (%)	N/A
N/A	Gutter Lip Ht (in)	0.0	N/A	Gutter X Slope (%)	N/A
N/A	Painted X Walk1?	No		Road Slope (%)	0.7
	X Walk 1 Direction	To S		Road X Slope (%)	1.6
	X Walk 1 Width (in)	N/A		Clear Space?	N/A

X Walk 1 Slope (%)	0.7	N/A	Clear Space to XWalk (in)	N/A
	X Walk 1 X Slope (%)	1.6	N/A	Storm Grate/Utility Hazard?	N/A
N/A	Ramp inside XWalk1?	N/A		Storm Grate/Utility Type	
N/A	Any Obstructions?	N/A			N/A
	Obstruction Type		Yes	Surface Condition? (G/P)	Good
			N/A	Curb Slope (%)	17.3

Remove & Replace Entire Ramp.

Total Cost: \$ 1600.00
