Access Compliance Report

Public Rights-of-Way

(Curb Ramps)

Intersection ID: 10025569	Main Street: E_W_T_HARRIS_BV	Cross Street: N/A	Location: NE
ADA ID: A540A6D71B97	Ramp Type: PerpDiag	Initial Pass/Fail: Fail	Overall Compliance: No
Codes/Mitigation Info/Possible Solution		Field Measurements/Component Compliance

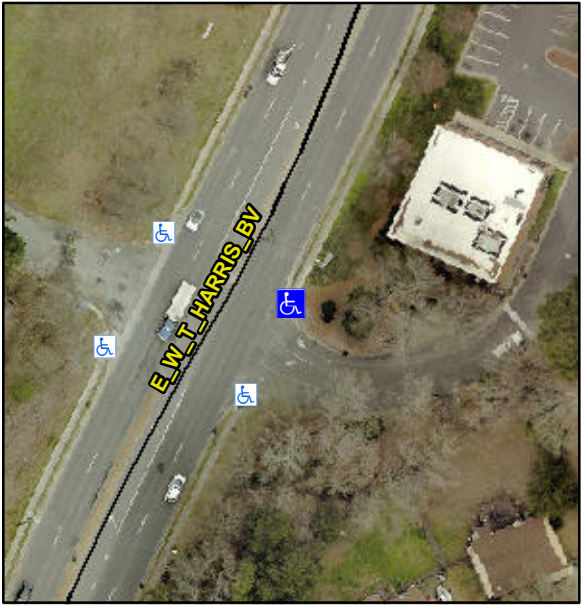
Possible Solutions:						
	Remove & Replace Curb Ramp With Two New Directional Ramps or Equivalent.						
	Surveyor Notes:						
	N/A						
	PROW/ADA:						
	R304.5.1, R304.2.2, R304.5.3						
Street 1 Name	E W T HARRIS BV	Compliance	Description	Data	Compliance	Description	Data
Stop Condition-Street 2	None	N/A	Ramp Length (in)	69.0	No	Ramp Slope (%)	8.4
Street 2 Name	ENTRANCE	No	Ramp Width (in)	36.0	No	Ramp XSlope (%)	5.3
Stop Condition-Street 1	StopSign	N/A	Flare Type LT	N/A	N/A	Flare Type RT	N/A
		N/A	Flare Slope LT (%)	N/A	N/A	Flare Slope RT (%)	N/A
		N/A	Flare Traversable LT?	N/A	N/A	Flare Traversable RT?	N/A
		N/A	Landing Length (in)	N/A	N/A	DWS Provided?	N/A
		N/A	Landing Width (in)	N/A	N/A	DWS Contrast?	N/A
		N/A	Landing Slope (%)	N/A	N/A	DWS Length (in)	N/A
		N/A	Landing X Slope (%)	N/A	N/A	DWS Full Width?	N/A
		N/A	Landing Curb? (Y/N)	N/A	N/A	DWS Offset (in)	N/A
		N/A	Shared Landing?	N/A			
		N/A	Gutter Ponding?	N/A	N/A	Gutter Slope (%)	N/A

N/A	Gutter Lip Ht (in)	N/A	N/A	Gutter X Slope (%)	N/A
		N/A	Painted X Walk1?	No	N/A	Painted X Walk2?	No
			X Walk 1 Direction	To NW		X Walk 2 Direction	To SW
		N/A	X Walk 1 Width (in)	N/A	N/A	X Walk 2 Width (in)	N/A
			X Walk 1 Slope (%)	2.9		X Walk 2 Slope (%)	6.8
			X Walk 1 X Slope (%)	3.2		X Walk 2 X Slope (%)	0.9
		N/A	Ramp inside XWalk1?	N/A	N/A	Ramp inside XWalk2?	N/A
			Road Slope (%)	4.5	N/A	Clear Space?	N/A
			Road X Slope (%)	6.8	N/A	Clear Space to XWalk (in)	N/A
		N/A	Any Obstructions?	N/A	N/A	Storm Grate/Utility Hazard?	N/A
			Obstruction Type			Storm Grate/Utility Type	
				N/A			N/A
					Yes	Surface Condition? (G/P)	Good
