# Access Compliance Report

## Public Rights-of-Way

### (Curb Ramps)

| Intersection ID: 43303 | Main Street: LANCASTER_HY | Cross Street: BALLANTYNE_GREEN_DR | Location: NW |

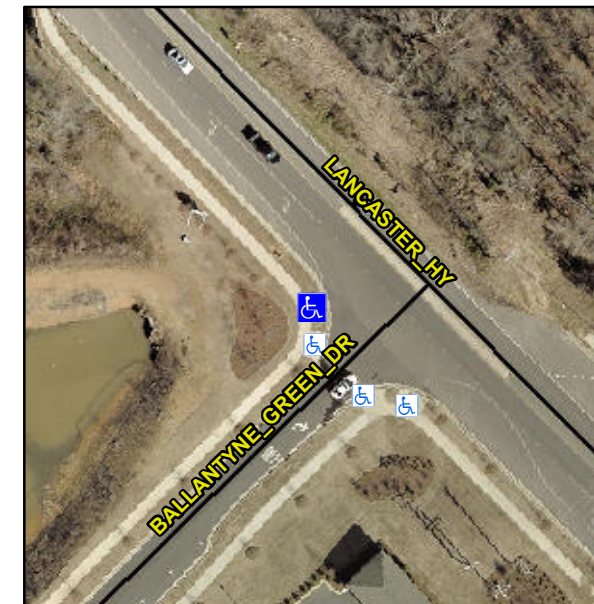
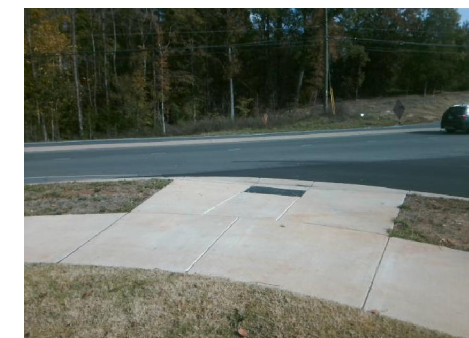
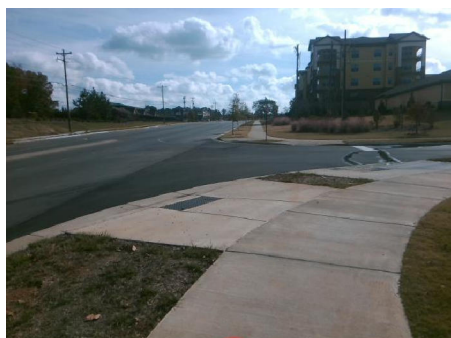
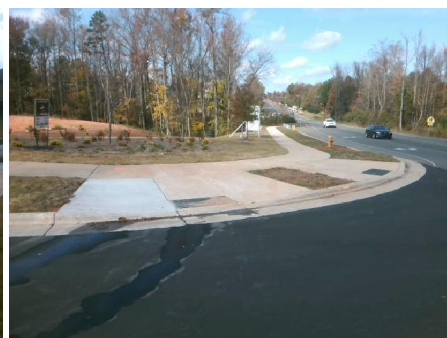
**Not Found, R304.5.1, R304.2.2, R304.5.3**

| Compliance | Description | Data | Compliance | Description | Data |
|---|---|---|---|---|---|
| N/A | Ramp Length (in) | 98.0 | No | Ramp Slope (%) | 8.6 |
| No | Ramp Width (in) | 46.5 | No | Ramp XSlope (%) | 4.5 |

**Remove & Replace Entire Ramp.**
