# Access Compliance Report

## Public Rights-of-Way

| Intersection ID: 5243 | Main Street: CHIDLEY_DR | Cross Street: HUBBARD_RD | Location: NE |
| ADA ID: A548A4D419BC | Ramp Type: Perp | Initial Pass/Fail: Fail | Overall Compliance: No |

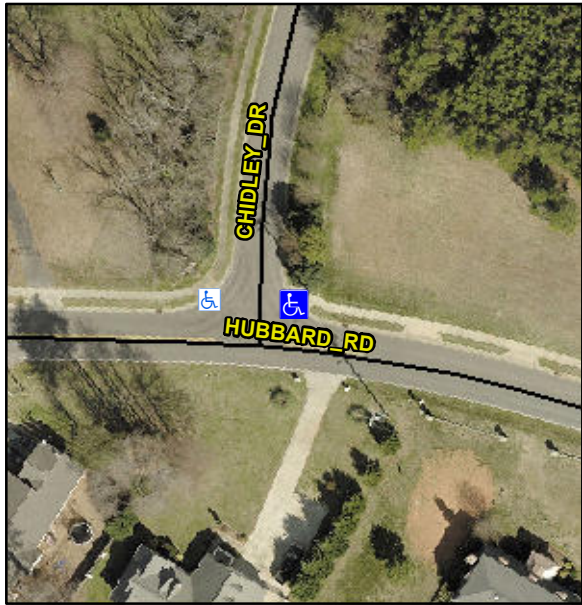
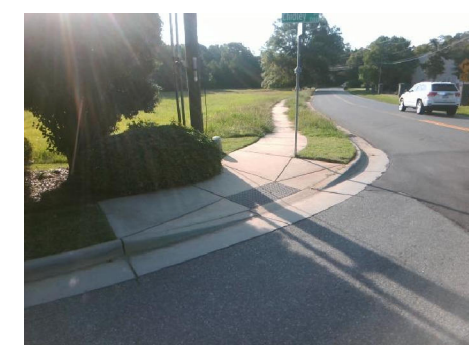
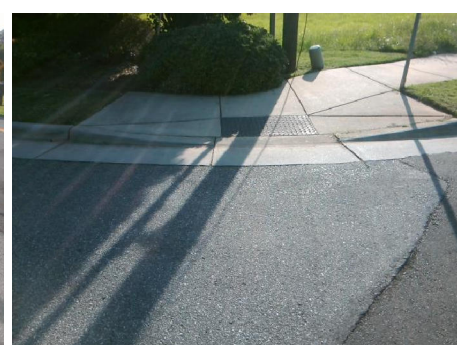
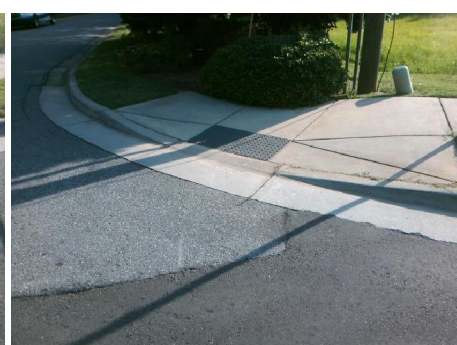
| | | | Severity Score: 13.75 |

| Codes/Mitigation Info/Possible Solution | | | Field Measurements/Component Compliance | | | | | |
|--|---|---|---|---|---|---|---|---|
| | Remove & Replace Entire Ramp. | | N/A | Ramp Length (in) | 48.0 | No | Ramp Slope (%) | 10.5 |
| | | | Yes | Ramp Width (in) | 48.0 | No | Ramp XSlope (%) | 2.2 |
| | Not Found, R304.2.2, R304.5.3 | | N/A | Gutter Lip Ht (in) | N/A | N/A | Gutter X Slope (%) | N/A |

| Codes/Mitigation Info/Possible Solution | | | Field Measurements/Component Compliance | | | | | |
|--|---|---|---|---|---|---|---|---|
| | Possible Solutions: | | Compliance | Description | Data | Compliance | Description | Data |
