Access Compliance Report

Public Rights-of-Way

(Curb Ramps)

Intersection ID: 15036	Main Street: MAGNOLIA_AV	Cross Street: MCDONALD_AV	Location: NE
ADA ID: A54B84F2ECD3	Ramp Type: Perp	Initial Pass/Fail: Fail	Overall Compliance: No
		Severity Score: 50

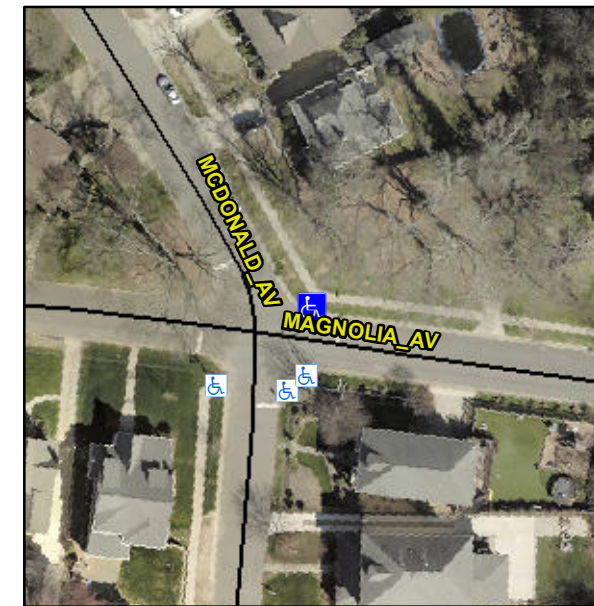
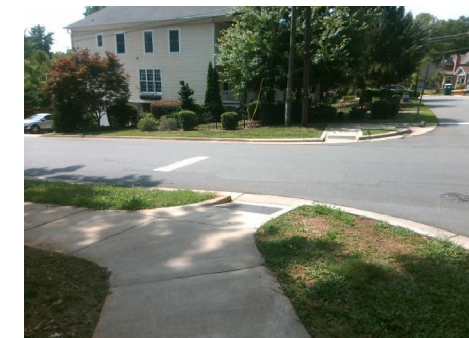
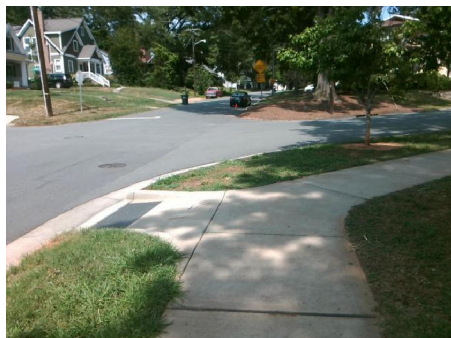
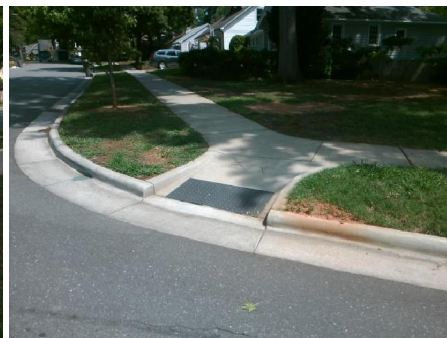
Compliance	Description	Data	Compliance	Description	Data
N/A	Ramp Length (in)	76.0	No	Ramp Slope (%)	14.1
Yes	Ramp Width (in)	55.0	No	Ramp XSlope (%)	8.2
N/A	Flare Type LT	N/A	N/A	Flare Type RT	N/A
N/A	Flare Slope LT (%)	N/A	N/A	Flare Slope RT (%)	N/A
N/A	Flare Traversable LT?	N/A	N/A	Flare Traversable RT?	N/A
N/A	Landing Length (in)	N/A	N/A	DWS Provided?	N/A
N/A	Landing Width (in)	N/A	N/A	DWS Contrast?	N/A
N/A	Landing Slope (%)	N/A	N/A	DWS Length (in)	N/A
N/A	Landing X Slope (%)	N/A	N/A	DWS Full Width?	N/A
N/A	Landing Curb? (Y/N)	N/A	N/A	DWS Offset (in)	N/A
N/A	Shared Landing?	N/A			
N/A	Gutter Ponding?	N/A	N/A	Gutter Slope (%)	N/A
N/A	Gutter Lip Ht (in)	1.0	N/A	Gutter X Slope (%)	N/A
N/A	Painted X Walk1?	No	N/A	Painted X Walk2?	N/A
	X Walk 1 Direction	To S		X Walk 2 Direction	N/A
N/A	X Walk 1 Width (in)	N/A	N/A	X Walk 2 Width (in)	N/A
	X Walk 1 Slope (%)	1.3		X Walk 2 Slope (%)	N/A
	X Walk 1 X Slope (%)	6.2		X Walk 2 X Slope (%)	N/A

N/A	Ramp inside XWalk1?	N/A	N/A	Ramp inside XWalk2?	N/A
	Road Slope (%)	N/A	N/A	Clear Space?	N/A
	Road X Slope (%)	N/A	N/A	Clear Space to XWalk (in)	N/A
N/A	Any Obstructions?	N/A	N/A	Storm Grate/Utility Hazard?	N/A
	Obstruction Type			Storm Grate/Utility Type	
		N/A			N/A
			Yes	Surface Condition? (G/P)	Good

Remove & Replace Entire Ramp.

R304.2.2, R304.5.3

\$ 1850.00
