# Access Compliance Report

## Public Rights-of-Way

### (Curb Ramps)

Intersection ID: 10025513	Main Street: E_MOREHEAD_ST	Cross Street: N/A	Location: S
ADA ID: A54C1C1B091F	Ramp Type: BlendTrans1	Initial Pass/Fail: Fail	Overall Compliance: No
			Severity Score: 21.25

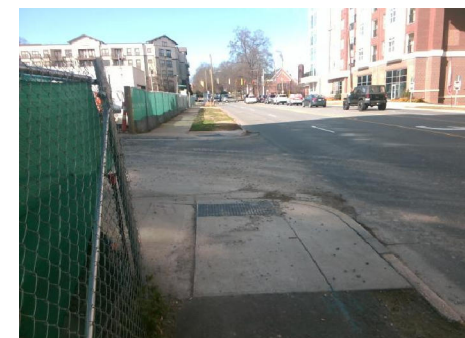
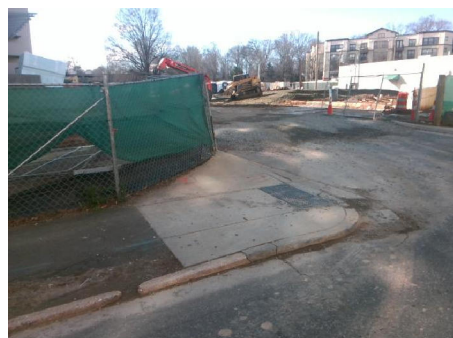
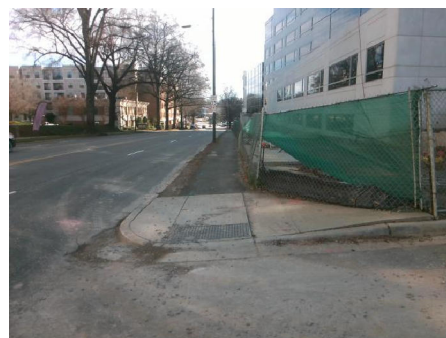
**Not Found, R304.5.1, R304.5.3**

Compliance	Description	Data	Compliance	Description	Data
N/A	Ramp Length (in)	108.0	Yes	BlendTrans Slope (%)	0.5
No	Ramp Width (in)	46.0	No	BlendTrans XSlope (%)	5.3
N/A	Flare Type LT	N/A	N/A	Flare Type RT	N/A
N/A	Flare Slope LT (%)	N/A	N/A	Flare Slope RT (%)	N/A
N/A	Flare Traversable LT?	N/A	N/A	Flare Traversable RT?	N/A
N/A	Landing Length (in)	N/A	N/A	DWS Provided?	N/A
N/A	Landing Width (in)	N/A	N/A	DWS Contrast?	N/A
N/A	Landing Slope (%)	N/A	N/A	DWS Length (in)	N/A
N/A	Landing X Slope (%)	N/A	N/A	DWS Full Width?	N/A
N/A	Landing Curb? (Y/N)	N/A	N/A	DWS Offset (in)	N/A
N/A	Shared Landing?	N/A			
N/A	Gutter Ponding?	N/A	N/A	Gutter Slope (%)	N/A
N/A	Gutter Lip Ht (in)	N/A	N/A	Gutter X Slope (%)	N/A
N/A	Painted X Walk1?	No	N/A	Painted X Walk2?	N/A
	X Walk 1 Direction	To NW		X Walk 2 Direction	N/A
	X Walk 1 Width (in)	N/A		X Walk 2 Width (in)	N/A
	X Walk 1 Slope (%)	2.4		X Walk 2 Slope (%)	N/A
	X Walk 1 X Slope (%)	3.7		X Walk 2 X Slope (%)	N/A

N/A	Ramp inside XWalk1?	N/A	N/A	Ramp inside XWalk2?	N/A
	Road Slope (%)	3.7		Clear Space?	N/A
	Road X Slope (%)	2.4	N/A	Clear Space to XWalk (in)	N/A
N/A	Any Obstructions?	N/A	N/A	Storm Grate/Utility Hazard?	N/A
	Obstruction Type			Storm Grate/Utility Type	
		N/A			N/A
			Yes	Surface Condition? (G/P)	Good
			No	Curb Slope (%)	13.0

**Remove & Replace Curb Ramp With Two New Directional Ramps or Equivalent.**
