# Access Compliance Report

## Public Rights-of-Way

### (Curb Ramps)

Intersection ID: 48570	Main Street: MATLEA_CT	Cross Street: RED_SQUIRREL_TL	Location: SW
ADA ID: A5520E936033	Ramp Type: Perp	Initial Pass/Fail: Fail	Overall Compliance: No
Severity Score: 13.75			
Codes/Mitigation Info/Possible Solution		Field Measurements/Component Compliance

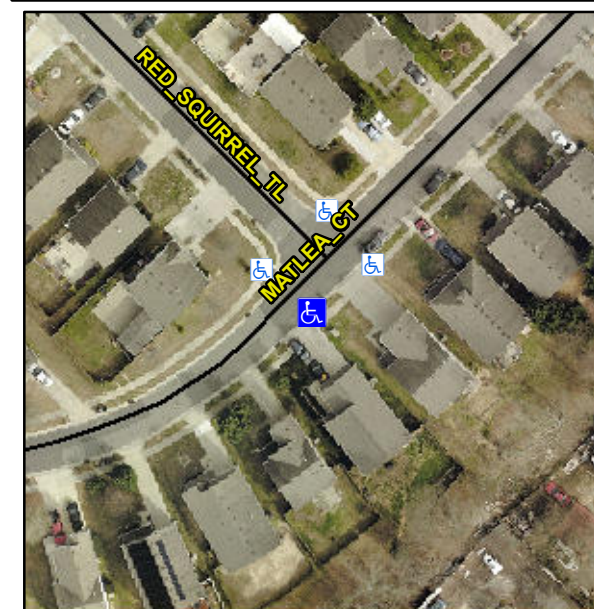
**Not Found, R304.2.2, R304.5.3**

Compliance	Description	Data	Compliance	Description	Data
N/A	Ramp Length (in)	44.5	No	Ramp Slope (%)	8.6
Yes	Ramp Width (in)	48.0	No	Ramp XSlope (%)	2.7
N/A	Flare Type LT	N/A	N/A	Flare Type RT	N/A
N/A	Flare Slope LT (%)	N/A	N/A	Flare Slope RT (%)	N/A
N/A	Flare Traversable LT?	N/A	N/A	Flare Traversable RT?	N/A
N/A	Landing Length (in)	N/A	N/A	DWS Provided?	N/A
N/A	Landing Width (in)	N/A	N/A	DWS Contrast?	N/A
N/A	Landing Slope (%)	N/A	N/A	DWS Length (in)	N/A
N/A	Landing X Slope (%)	N/A	N/A	DWS Full Width?	N/A
N/A	Landing Curb? (Y/N)	N/A	N/A	DWS Offset (in)	N/A
N/A	Shared Landing?	N/A			
N/A	Gutter Ponding?	N/A	N/A	Gutter Slope (%)	N/A
N/A	Gutter Lip Ht (in)	N/A	N/A	Gutter X Slope (%)	N/A
N/A	Painted X Walk1?	No	N/A	Painted X Walk2?	N/A
	X Walk 1 Direction	To NW		X Walk 2 Direction	N/A
N/A	X Walk 1 Width (in)	N/A	N/A	X Walk 2 Width (in)	N/A
	X Walk 1 Slope (%)	4.7		X Walk 2 Slope (%)	N/A
	X Walk 1 X Slope (%)	1.5		X Walk 2 X Slope (%)	N/A

N/A	Ramp inside XWalk1?	N/A	N/A	Ramp inside XWalk2?	N/A
	Road Slope (%)	N/A	N/A	Clear Space?	N/A
	Road X Slope (%)	N/A	N/A	Clear Space to XWalk (in)	N/A
N/A	Any Obstructions?	N/A	N/A	Storm Grate/Utility Hazard?	N/A
	Obstruction Type			Storm Grate/Utility Type	
		N/A			N/A
			Yes	Surface Condition? (G/P)	Good

**Remove & Replace Entire Ramp.**
