Access Compliance Report

Public Rights-of-Way

(Curb Ramps)

Intersection ID: 43493	Main Street: BIRCHFIELD_CT	Cross Street: CHESLEY_DR	Location:	NE
ADA ID: A5569FB017F3	Ramp Type: BlendTrans1	Initial Pass/Fail: Fail	Overall Compliance: No	Severity Score: 10
Codes/Mitigation Info/Possible Solution		Field Measurements/Component Compliance

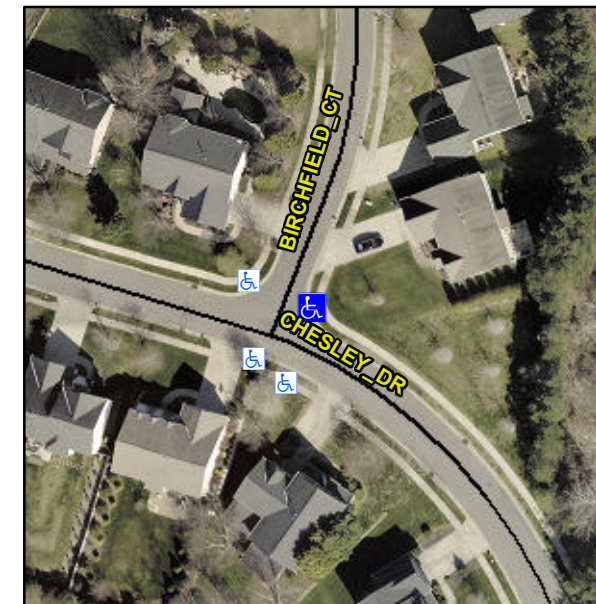
Not Found, R304.5.1, R304.5.3

Compliance	Description	Data	Compliance	Description	Data
N/A	Ramp Length (in)	48.0	Yes	BlendTrans Slope (%)	4.8
No	Ramp Width (in)	41.0	No	BlendTrans XSlope (%)	4.4
N/A	Flare Type LT	N/A	N/A	Flare Type RT	N/A
N/A	Flare Slope LT (%)	N/A	N/A	Flare Slope RT (%)	N/A
N/A	Flare Traversable LT?	N/A	N/A	Flare Traversable RT?	N/A
N/A	Landing Length (in)	N/A	N/A	DWS Provided?	N/A
N/A	Landing Width (in)	N/A	N/A	DWS Contrast?	N/A
N/A	Landing Slope (%)	N/A	N/A	DWS Length (in)	N/A
N/A	Landing X Slope (%)	N/A	N/A	DWS Full Width?	N/A
N/A	Landing Curb? (Y/N)	N/A	N/A	DWS Offset (in)	N/A
N/A	Shared Landing?	N/A			
N/A	Gutter Ponding?	N/A	N/A	Gutter Slope (%)	N/A
N/A	Gutter Lip Ht (in)	1.5	N/A	Gutter X Slope (%)	N/A
N/A	Painted X Walk1?	No	N/A	Painted X Walk2?	No
	X Walk 1 Direction	To NW		X Walk 2 Direction	To S
	X Walk 1 Width (in)	N/A		X Walk 2 Width (in)	N/A
	X Walk 1 Slope (%)	8.3		X Walk 2 Slope (%)	3.6
	X Walk 1 X Slope (%)	1.5		X Walk 2 X Slope (%)	7.3

N/A	Ramp inside XWalk1?	N/A	N/A	Ramp inside XWalk2?	N/A
	Road Slope (%)	4.0		Clear Space?	N/A
	Road X Slope (%)	5.4	N/A	Clear Space to XWalk (in)	N/A
N/A	Any Obstructions?	N/A	N/A	Storm Grate/Utility Hazard?	N/A
	Obstruction Type			Storm Grate/Utility Type	
		N/A			N/A
			Yes	Surface Condition? (G/P)	Good
			No	Curb Slope (%)	8.5

Remove & Replace Curb Ramp With Two New Directional Ramps or Equivalent.
