# Access Compliance Report

## Public Rights-of-Way

### (Curb Ramps)

| Intersection ID: 50631 | Main Street: CORAL_ROSE_RD | Cross Street: RUBY_VALLEY_RD | Location: NE |

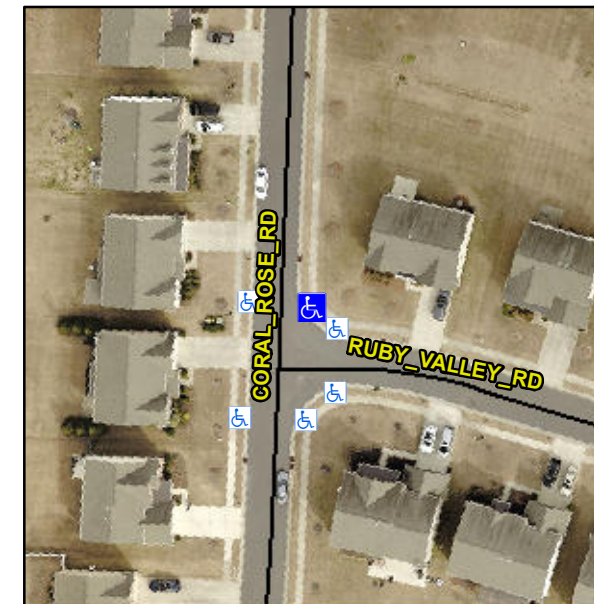
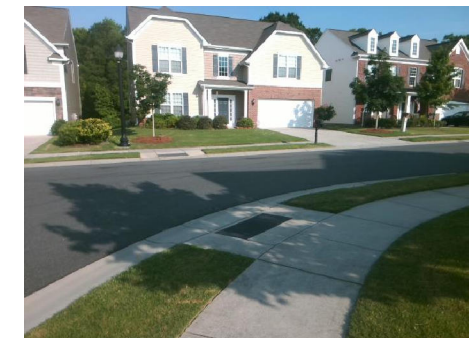
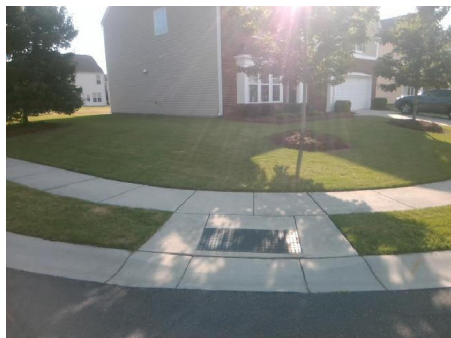
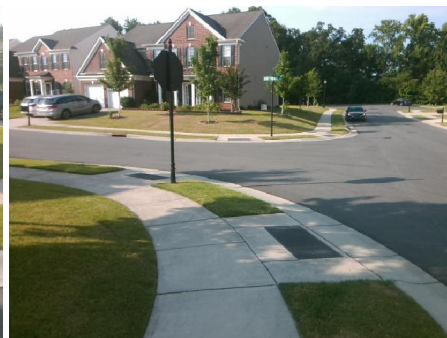
**Not Found, R304.5.1, R304.5.3**

| Compliance | Description | Data | Compliance | Description | Data |
|---|---|---|---|---|---|
| N/A | Ramp Length (in) | 47.0 | Yes | Ramp Slope (%) | 6.1 |
| No | Ramp Width (in) | 47.0 | No | Ramp XSlope (%) | 2.7 |

**Remove & Replace Entire Ramp.**

**\$ 1850.00**
