# Access Compliance Report

## Public Rights-of-Way

### (Curb Ramps)

| Intersection ID: 20093 | Main Street: FAIRVIEW_RD | Cross Street: CLOSEBURN_RD | Location: SW |

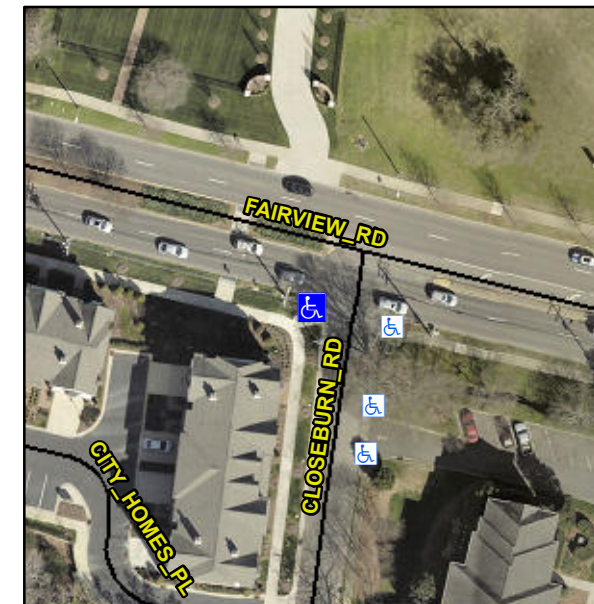
| ADA ID: A560C218DA50 | Ramp Type: BlendTrans2 | Initial Pass/Fail: Fail | Overall Compliance: No |
| | | Severity Score: 12.5 | |

**Not Found, R304.5.3**

| Compliance | Description | Data | Compliance | Description | Data |
|---|---|---|---|---|---|
| Yes | Ramp Width (in) | 60.0 | No | BlendTrans XSlope (%) | 5.1 |
| | | | No | Curb Slope (%) | 6.0 |

**Remove & Replace Curb Ramp With Two New Directional Ramps or Equivalent.**

Total Cost: \$ 3200.00
