Access Compliance Report

Public Rights-of-Way

(Curb Ramps)

Intersection ID: N/A	Main Street: SOUTHGROVE_ST	Cross Street: WAVERLY_CENTER_DR	Location: SW
ADA ID: A56DB98F30B2	Ramp Type: Perp	Initial Pass/Fail: Fail	Overall Compliance: No
Severity Score: 21.25			
Codes/Mitigation Info/Possible Solution		Field Measurements/Component Compliance

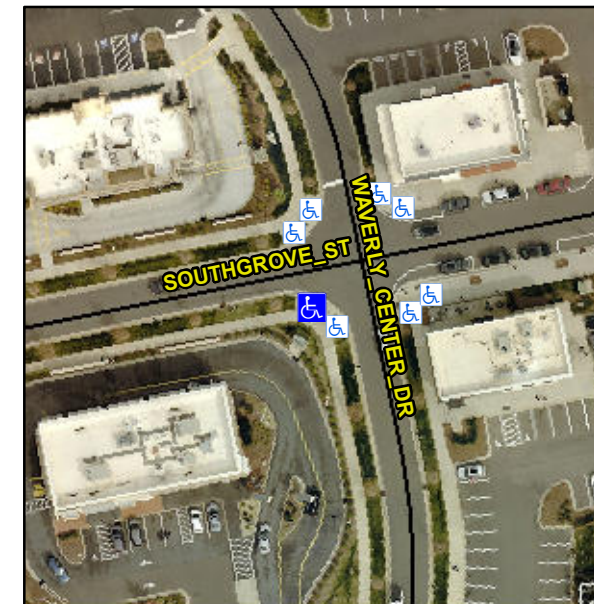
Not Found, R304.5.1, R304.2.2

Compliance	Description	Data	Compliance	Description	Data
N/A	Ramp Length (in)	95.0	No	Ramp Slope (%)	8.6
No	Ramp Width (in)	46.0	Yes	Ramp XSlope (%)	1.4
N/A	Flare Type LT	N/A	N/A	Flare Type RT	N/A
N/A	Flare Slope LT (%)	N/A	N/A	Flare Slope RT (%)	N/A
N/A	Flare Traversable LT?	N/A	N/A	Flare Traversable RT?	N/A
N/A	Landing Length (in)	N/A	N/A	DWS Provided?	N/A
N/A	Landing Width (in)	N/A	N/A	DWS Contrast?	N/A
N/A	Landing Slope (%)	N/A	N/A	DWS Length (in)	N/A
N/A	Landing X Slope (%)	N/A	N/A	DWS Full Width?	N/A
N/A	Landing Curb? (Y/N)	N/A	N/A	DWS Offset (in)	N/A
N/A	Shared Landing?	N/A			
N/A	Gutter Ponding?	N/A	N/A	Gutter Slope (%)	N/A
N/A	Gutter Lip Ht (in)	N/A	N/A	Gutter X Slope (%)	N/A
N/A	Painted X Walk1?	No	N/A	Painted X Walk2?	N/A
	X Walk 1 Direction	To N		X Walk 2 Direction	N/A
N/A	X Walk 1 Width (in)	N/A	N/A	X Walk 2 Width (in)	N/A
	X Walk 1 Slope (%)	3.6		X Walk 2 Slope (%)	N/A
	X Walk 1 X Slope (%)	1.4		X Walk 2 X Slope (%)	N/A

N/A	Ramp inside XWalk1?	N/A	N/A	Ramp inside XWalk2?	N/A
	Road Slope (%)	N/A	N/A	Clear Space?	N/A
	Road X Slope (%)	N/A	N/A	Clear Space to XWalk (in)	N/A
N/A	Any Obstructions?	N/A	N/A	Storm Grate/Utility Hazard?	N/A
	Obstruction Type			Storm Grate/Utility Type	
		N/A			N/A
			Yes	Surface Condition? (G/P)	Good

Possible Solutions:

Remove & Replace Entire Ramp.
