Access Compliance Report

Public Rights-of-Way

(Curb Ramps)

Intersection ID: 17205	Main Street: LINDA_LN	Cross Street: WALKER_RD	Location: NW
ADA ID: A5731C91F031	Ramp Type: ParaDiag	Initial Pass/Fail: Fail	Overall Compliance: No
Severity Score: 48.75			
Codes/Mitigation Info/Possible Solution		Field Measurements/Component Compliance

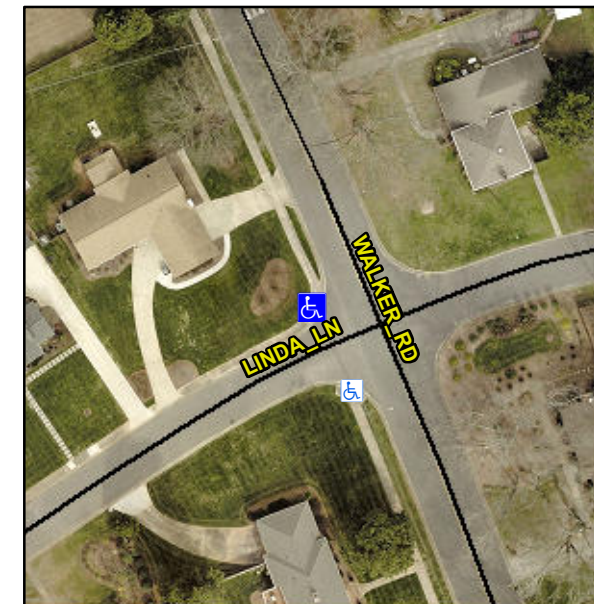
LT RP < 5%

R304.5.1, R304.5.3, R304.3.2

Compliance	Description	Data	Compliance	Description	Data
N/A	Ramp Length LT (in)	59.0	N/A	Ramp Length RT (in)	63.0
No	Ramp Width LT (in)	30.0	No	Ramp Width RT (in)	34.0
Yes	Ramp Slope LT (%)	2.3	No	Ramp Slope RT (%)	8.5
No	Ramp XSlope LT (%)	2.7	Yes	Ramp XSlope RT (%)	1.9
N/A	Landing Length (in)	N/A	N/A	DWS Provided?	N/A
N/A	Landing Width (in)	N/A	N/A	DWS Contrast?	N/A
N/A	Landing Slope (%)	N/A	N/A	DWS Length (in)	N/A
N/A	Landing X Slope (%)	N/A	N/A	DWS Full Width?	N/A
N/A	Landing Curb? (Y/N)	N/A	N/A	DWS Offset (in)	N/A
N/A	Shared Landing?	N/A			
N/A	Gutter Ponding?	N/A	N/A	Gutter Slope (%)	N/A
N/A	Gutter Lip Ht (in)	N/A	N/A	Gutter X Slope (%)	N/A
N/A	Painted X Walk1?	No	N/A	Painted X Walk2?	No
	X Walk 1 Direction	To SE		X Walk 2 Direction	To NE
N/A	X Walk 1 Width (in)	N/A	N/A	X Walk 2 Width (in)	N/A
	X Walk 1 Slope (%)	1.1		X Walk 2 Slope (%)	1.8
	X Walk 1 X Slope (%)	1.8		X Walk 2 X Slope (%)	0.8
N/A	Ramp inside XWalk1?	N/A	N/A	Ramp inside XWalk2?	N/A

Road Slope (%)	1.6	N/A	Clear Space?	N/A
	Road X Slope (%)	1.2	N/A	Clear Space to XWalk (in)	N/A
N/A	Any Obstructions?	N/A	N/A	Storm Grate/Utility Hazard?	N/A
	Obstruction Type			Storm Grate/Utility Type	
		N/A			N/A
			Yes	Surface Condition? (G/P)	Good
			N/A	Curb Slope (%)	9.2

Possible Solutions:

Remove & Replace Curb Ramp With Two New Directional Ramps or Equivalent.
