Access Compliance Report

Public Rights-of-Way

(Curb Ramps)

Intersection ID: 13872	Main Street: S_TRYON_ST	Cross Street: W_WORTHINGTON_AV	Location: SW
ADA ID: A57BE60DC3C8	Ramp Type: Perp	Initial Pass/Fail: Fail	Overall Compliance: No
Severity Score: 25			
Codes/Mitigation Info/Possible Solution		Field Measurements/Component Compliance

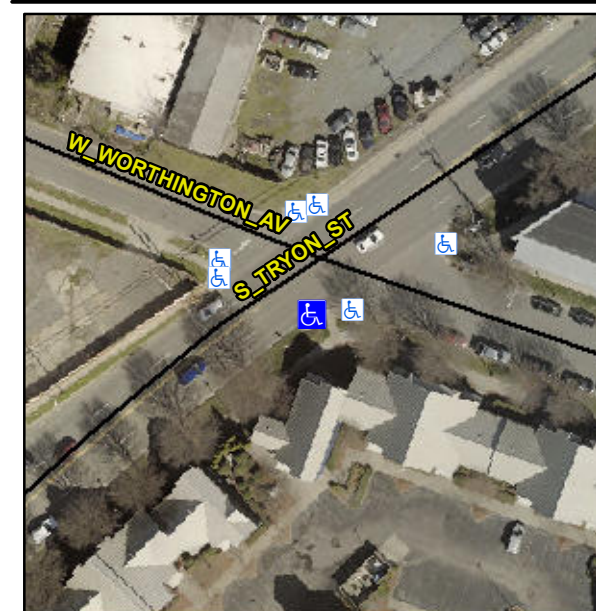
Not Found, R304.2.2, R304.5.3

Compliance	Description	Data	Compliance	Description	Data
N/A	Ramp Length (in)	60.0	No	Ramp Slope (%)	10.0
Yes	Ramp Width (in)	48.0	No	Ramp XSlope (%)	6.4
N/A	Flare Type LT	N/A	N/A	Flare Type RT	N/A
N/A	Flare Slope LT (%)	N/A	N/A	Flare Slope RT (%)	N/A
N/A	Flare Traversable LT?	N/A	N/A	Flare Traversable RT?	N/A
N/A	Landing Length (in)	N/A	N/A	DWS Provided?	N/A
N/A	Landing Width (in)	N/A	N/A	DWS Contrast?	N/A
N/A	Landing Slope (%)	N/A	N/A	DWS Length (in)	N/A
N/A	Landing X Slope (%)	N/A	N/A	DWS Full Width?	N/A
N/A	Landing Curb? (Y/N)	N/A	N/A	DWS Offset (in)	N/A
N/A	Shared Landing?	N/A			
N/A	Gutter Ponding?	N/A	N/A	Gutter Slope (%)	N/A
N/A	Gutter Lip Ht (in)	N/A	N/A	Gutter X Slope (%)	N/A
N/A	Painted X Walk1?	No	N/A	Painted X Walk2?	N/A
	X Walk 1 Direction	To NW		X Walk 2 Direction	N/A
N/A	X Walk 1 Width (in)	N/A	N/A	X Walk 2 Width (in)	N/A
	X Walk 1 Slope (%)	0.7		X Walk 2 Slope (%)	N/A
	X Walk 1 X Slope (%)	5.7		X Walk 2 X Slope (%)	N/A

N/A	Ramp inside XWalk1?	N/A	N/A	Ramp inside XWalk2?	N/A
	Road Slope (%)	N/A	N/A	Clear Space?	N/A
	Road X Slope (%)	N/A	N/A	Clear Space to XWalk (in)	N/A
N/A	Any Obstructions?	N/A	N/A	Storm Grate/Utility Hazard?	N/A
	Obstruction Type			Storm Grate/Utility Type	
		N/A			N/A
			Yes	Surface Condition? (G/P)	Good

Possible Solutions:

Remove & Replace Entire Ramp.
