Access Compliance Report

Public Rights-of-Way

(Curb Ramps)

Intersection ID: N/A	Main Street: BLAKENEY PROFESSIONAL DR	Cross Street: BISHOP CREST LN	Location: SW
ADA ID: A58467D0BC22	Ramp Type: BlendTrans2	Initial Pass/Fail: Fail	Overall Compliance: No
Severity Score: 10			
Codes/Mitigation Info/Possible Solution		Field Measurements/Component Compliance

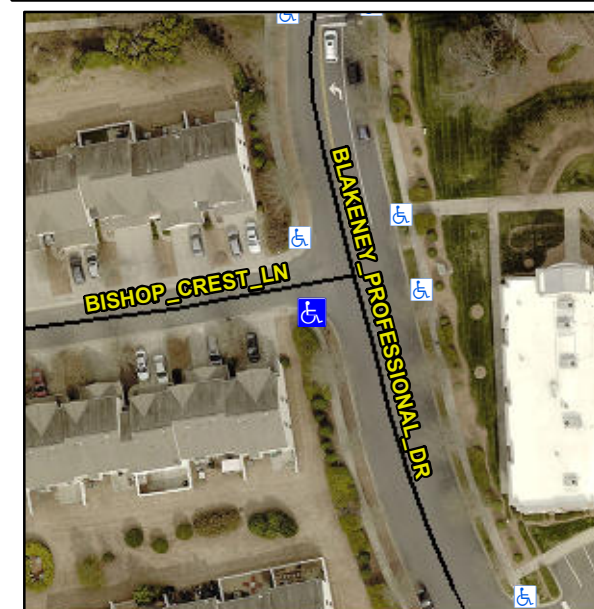
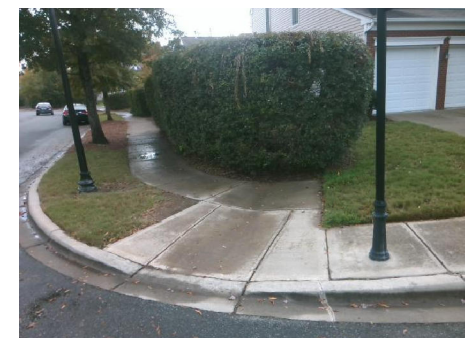
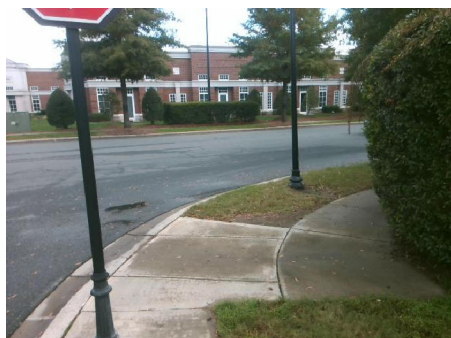
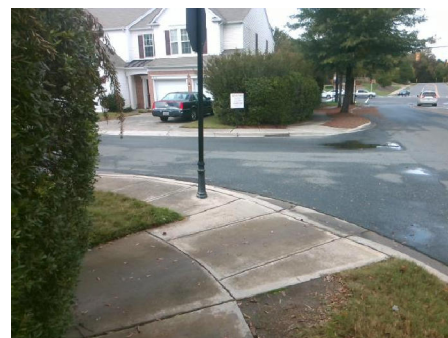
R304.5.1, R304.5.3

Compliance	Description	Data	Compliance	Description	Data
N/A	Ramp Length (in)	132.0	Yes	BlendTrans Slope (%)	3.7
No	Ramp Width (in)	46.0	No	BlendTrans XSlope (%)	2.7
N/A	Flare Type LT	N/A	N/A	Flare Type RT	N/A
N/A	Flare Slope LT (%)	N/A	N/A	Flare Slope RT (%)	N/A
N/A	Flare Traversable LT?	N/A	N/A	Flare Traversable RT?	N/A
N/A	Landing Length (in)	N/A	N/A	DWS Provided?	N/A
N/A	Landing Width (in)	N/A	N/A	DWS Contrast?	N/A
N/A	Landing Slope (%)	N/A	N/A	DWS Length (in)	N/A
N/A	Landing X Slope (%)	N/A	N/A	DWS Full Width?	N/A
N/A	Landing Curb? (Y/N)	N/A	N/A	DWS Offset (in)	N/A
N/A	Shared Landing?	N/A			
N/A	Gutter Ponding?	N/A	N/A	Gutter Slope (%)	N/A
N/A	Gutter Lip Ht (in)	N/A	N/A	Gutter X Slope (%)	N/A
N/A	Painted X Walk1?	No	N/A	Painted X Walk2?	No
	X Walk 1 Direction	To E		X Walk 2 Direction	To N
	X Walk 1 Width (in)	N/A		X Walk 2 Width (in)	N/A
	X Walk 1 Slope (%)	0.2		X Walk 2 Slope (%)	1.3
	X Walk 1 X Slope (%)	0.6		X Walk 2 X Slope (%)	0.9

N/A	Ramp inside XWalk1?	N/A	N/A	Ramp inside XWalk2?	N/A
	Road Slope (%)	1.6		Clear Space?	N/A
	Road X Slope (%)	0.1	N/A	Clear Space to XWalk (in)	N/A
N/A	Any Obstructions?	N/A	N/A	Storm Grate/Utility Hazard?	N/A
	Obstruction Type			Storm Grate/Utility Type	
		N/A			N/A
			Yes	Surface Condition? (G/P)	Good
			N/A	Curb Slope (%)	2.5

Remove & Replace Curb Ramp With Two New Directional Ramps or Equivalent.
