# Access Compliance Report

## Public Rights-of-Way

### (Curb Ramps)

| Intersection ID: 10033676 | Main Street: ORCHARD_LAKE_DR | Cross Street: N/A | Location: S |

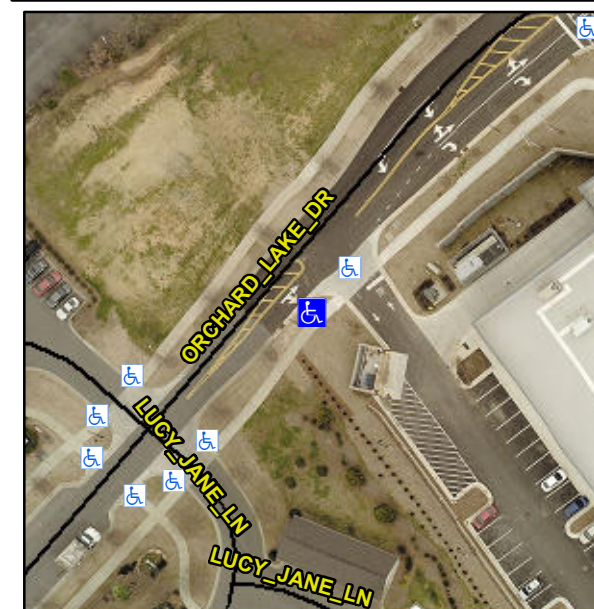
**NO CURB**

**R304.5.3, R304.2.2-Perp, R304.3.2-  
Para, R304.5.2, R305.1.4**

| Compliance | Description | Data | Compliance | Description | Data |
|---|---|---|---|---|---|
| No | Ramp XSlope (%) | 3.1 | | | |
| No | Landing Slope (%) | 2.5 | Yes | DWS Length (in) | 24.0 |
| Yes | Landing X Slope (%) | 1.8 | No | DWS Full Width? | No |
| Yes | Gutter Lip Ht (in) | 0.0 | No | Gutter X Slope (%) | 3.3 |

**Remove & Replace Entire Ramp.  
Remove & Replace Gutter.**
