Access Compliance Report

Public Rights-of-Way

(Curb Ramps)

Intersection ID: 7076	Main Street: ACORN_OAKS_RD	Cross Street: BEGONIA_DR	Location:	N
ADA ID: A5873D095E04	Ramp Type: Perp	Initial Pass/Fail: Fail	Overall Compliance: No	Severity Score: 8.75
Codes/Mitigation Info/Possible Solution		Field Measurements/Component Compliance

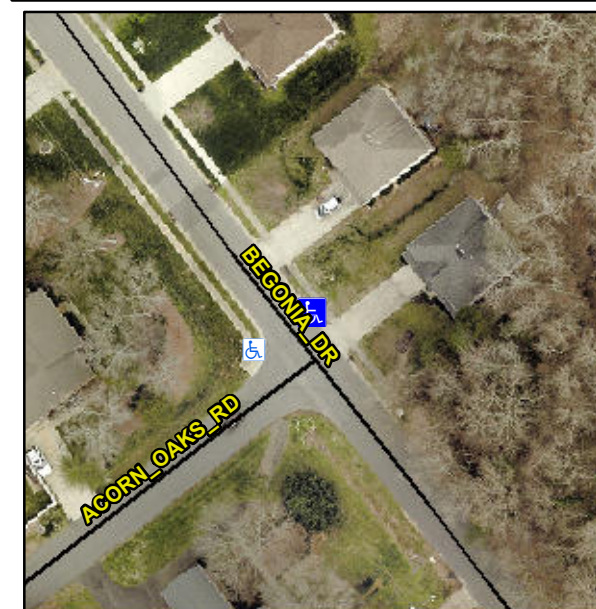
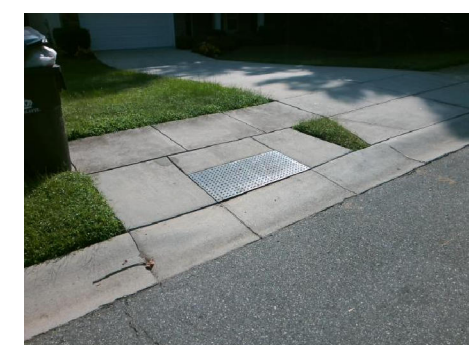
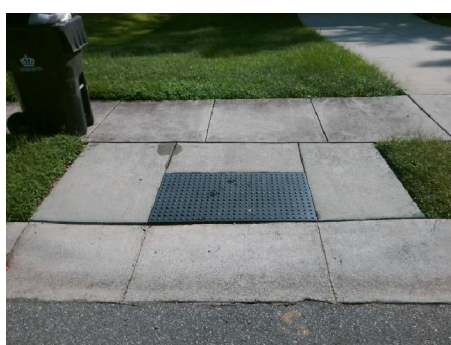
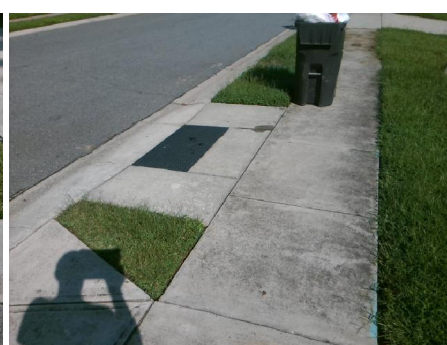
Not Found, R304.5.1

Compliance	Description	Data	Compliance	Description	Data
N/A	Ramp Length (in)	47.0	Yes	Ramp Slope (%)	6.1
No	Ramp Width (in)	47.5	Yes	Ramp XSlope (%)	1.7
N/A	Flare Type LT	N/A	N/A	Flare Type RT	N/A
N/A	Flare Slope LT (%)	N/A	N/A	Flare Slope RT (%)	N/A
N/A	Flare Traversable LT?	N/A	N/A	Flare Traversable RT?	N/A
N/A	Landing Length (in)	N/A	N/A	DWS Provided?	N/A
N/A	Landing Width (in)	N/A	N/A	DWS Contrast?	N/A
N/A	Landing Slope (%)	N/A	N/A	DWS Length (in)	N/A
N/A	Landing X Slope (%)	N/A	N/A	DWS Full Width?	N/A
N/A	Landing Curb? (Y/N)	N/A	N/A	DWS Offset (in)	N/A
N/A	Shared Landing?	N/A			
N/A	Gutter Ponding?	N/A	N/A	Gutter Slope (%)	N/A
N/A	Gutter Lip Ht (in)	N/A	N/A	Gutter X Slope (%)	N/A
N/A	Painted X Walk1?	No	N/A	Painted X Walk2?	N/A
	X Walk 1 Direction	To SW		X Walk 2 Direction	N/A
N/A	X Walk 1 Width (in)	N/A	N/A	X Walk 2 Width (in)	N/A
	X Walk 1 Slope (%)	3.5		X Walk 2 Slope (%)	N/A
	X Walk 1 X Slope (%)	2.1		X Walk 2 X Slope (%)	N/A

N/A	Ramp inside XWalk1?	N/A	N/A	Ramp inside XWalk2?	N/A
	Road Slope (%)	N/A	N/A	Clear Space?	N/A
	Road X Slope (%)	N/A	N/A	Clear Space to XWalk (in)	N/A
N/A	Any Obstructions?	N/A	N/A	Storm Grate/Utility Hazard?	N/A
	Obstruction Type			Storm Grate/Utility Type	
		N/A			N/A
			Yes	Surface Condition? (G/P)	Good

Remove & Replace Entire Ramp.
