Access Compliance Report

Public Rights-of-Way

(Curb Ramps)

Intersection ID: 15017	Main Street: BALTIMORE_AV	Cross Street: GRIFFITH_ST	Location: NW
ADA ID: A58FF4FAD444	Ramp Type: PerpDiag	Initial Pass/Fail: Fail	Overall Compliance: No
		Severity Score: 50

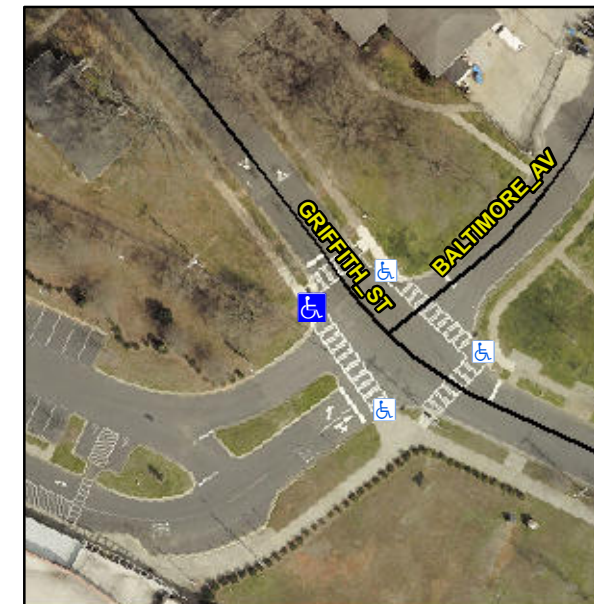
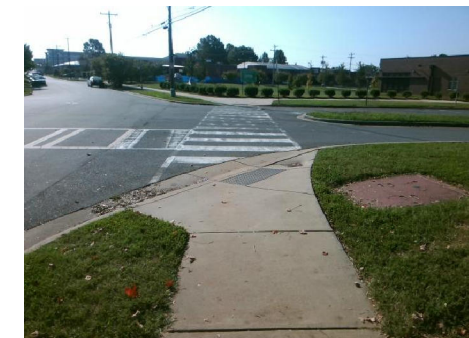
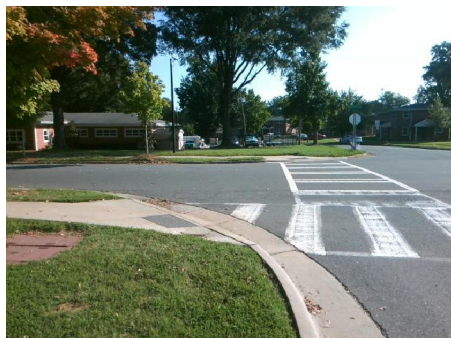
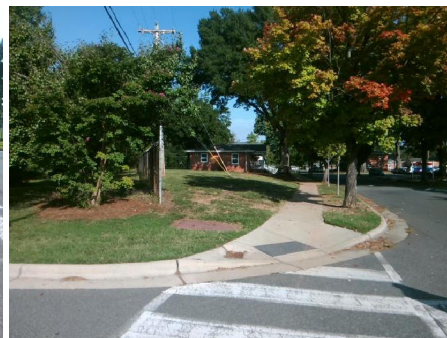
Not Found, R304.2.2, R304.5.3

Compliance	Description	Data	Compliance	Description	Data
N/A	Ramp Length (in)	49.0	No	Ramp Slope (%)	14.3
Yes	Ramp Width (in)	48.0	No	Ramp XSlope (%)	7.6
N/A	Flare Type LT	N/A	N/A	Flare Type RT	N/A
N/A	Flare Slope LT (%)	N/A	N/A	Flare Slope RT (%)	N/A
N/A	Flare Traversable LT?	N/A	N/A	Flare Traversable RT?	N/A
N/A	Landing Length (in)	N/A	N/A	DWS Provided?	N/A
N/A	Landing Width (in)	N/A	N/A	DWS Contrast?	N/A
N/A	Landing Slope (%)	N/A	N/A	DWS Length (in)	N/A
N/A	Landing X Slope (%)	N/A	N/A	DWS Full Width?	N/A
N/A	Landing Curb? (Y/N)	N/A	N/A	DWS Offset (in)	N/A
N/A	Shared Landing?	N/A			
N/A	Gutter Ponding?	N/A	N/A	Gutter Slope (%)	N/A
N/A	Gutter Lip Ht (in)	N/A	N/A	Gutter X Slope (%)	N/A
N/A	Painted X Walk1?	Yes	N/A	Painted X Walk2?	Yes
	X Walk 1 Direction	To SE		X Walk 2 Direction	To NE
N/A	X Walk 1 Width (in)	116.0	N/A	X Walk 2 Width (in)	110.0
	X Walk 1 Slope (%)	0.4		X Walk 2 Slope (%)	1.6
	X Walk 1 X Slope (%)	0.3		X Walk 2 X Slope (%)	0.9

N/A	Ramp inside XWalk1?	Yes	N/A	Ramp inside XWalk2?	No
	Road Slope (%)	2.6	N/A	Clear Space?	N/A
	Road X Slope (%)	2.3	N/A	Clear Space to XWalk (in)	N/A
N/A	Any Obstructions?	N/A	N/A	Storm Grate/Utility Hazard?	N/A
	Obstruction Type			Storm Grate/Utility Type	
		N/A			N/A
		Yes		Surface Condition? (G/P)	Good

Remove & Replace Curb Ramp With Two New Directional Ramps or Equivalent. Restripe Crosswalk.

Total Cost: \$ 3400.00
