Access Compliance Report

Public Rights-of-Way

(Curb Ramps)

Intersection ID: 13725	Main Street: AUBURNDALE_RD	Cross Street: N_SHARON_AMITY_RD	Location: SW
ADA ID: A59E32301754	Ramp Type: Perp	Initial Pass/Fail: Fail	Overall Compliance: No
			Severity Score: 21.25

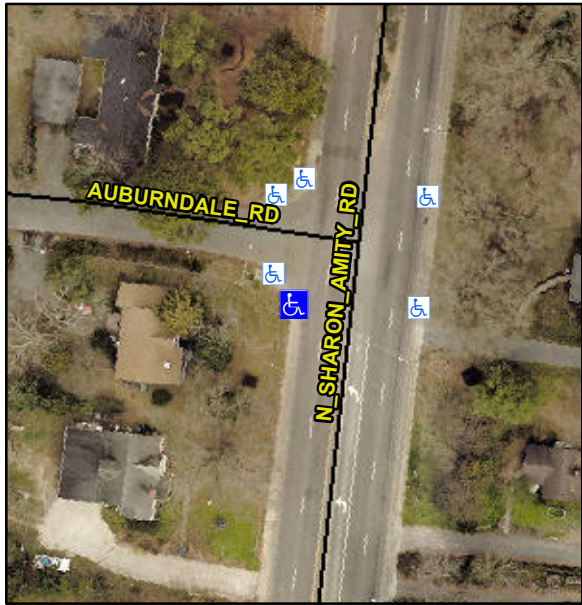
Possible Solutions:		Compliance	Description	Data	Compliance	Description	Data
	Remove & Replace Entire Ramp.		N/A	Ramp Length (in)	60.5	No	Ramp Slope (%)	10.1
			No	Ramp Width (in)	41.0	Yes	Ramp XSlope (%)	1.4
			N/A	Flare Type LT	N/A	N/A	Flare Type RT	N/A
			N/A	Flare Slope LT (%)	N/A	N/A	Flare Slope RT (%)	N/A
			N/A	Flare Traversable LT?	N/A	N/A	Flare Traversable RT?	N/A
			N/A	Landing Length (in)	N/A	N/A	DWS Provided?	N/A
			N/A	Landing Width (in)	N/A	N/A	DWS Contrast?	N/A
			N/A	Landing Slope (%)	N/A	N/A	DWS Length (in)	N/A
			N/A	Landing X Slope (%)	N/A	N/A	DWS Full Width?	N/A
Surveyor Notes:			N/A	Landing Curb? (Y/N)	N/A	N/A	DWS Offset (in)	N/A
N/A			N/A	Shared Landing?	N/A			
PROW/ADA:			N/A	Gutter Ponding?	N/A	N/A	Gutter Slope (%)	N/A
Not Found, R304.5.1, R304.2.2			N/A	Gutter Lip Ht (in)	N/A	N/A	Gutter X Slope (%)	N/A

N/A	Painted X Walk1?	No	N/A	Painted X Walk2?	N/A
				X Walk 1 Direction	To E		X Walk 2 Direction	N/A
			N/A	X Walk 1 Width (in)	N/A	N/A	X Walk 2 Width (in)	N/A
				X Walk 1 Slope (%)	3.4		X Walk 2 Slope (%)	N/A
				X Walk 1 X Slope (%)	1.5		X Walk 2 X Slope (%)	N/A
			N/A	Ramp inside XWalk1?	N/A	N/A	Ramp inside XWalk2?	N/A
				Road Slope (%)	N/A	N/A	Clear Space?	N/A
				Road X Slope (%)	N/A	N/A	Clear Space to XWalk (in)	N/A
			N/A	Any Obstructions?	N/A	N/A	Storm Grate/Utility Hazard?	N/A
				Obstruction Type			Storm Grate/Utility Type	
					N/A			N/A
						Yes	Surface Condition? (G/P)	Good
Total Cost:		\$ 1850.00
