# Access Compliance Report

## Public Rights-of-Way

### (Curb Ramps)

| Intersection ID: 48953 | Main Street: DAVID_JENNINGS_AV | Cross Street: GATESMILLS_AV | Location: E |

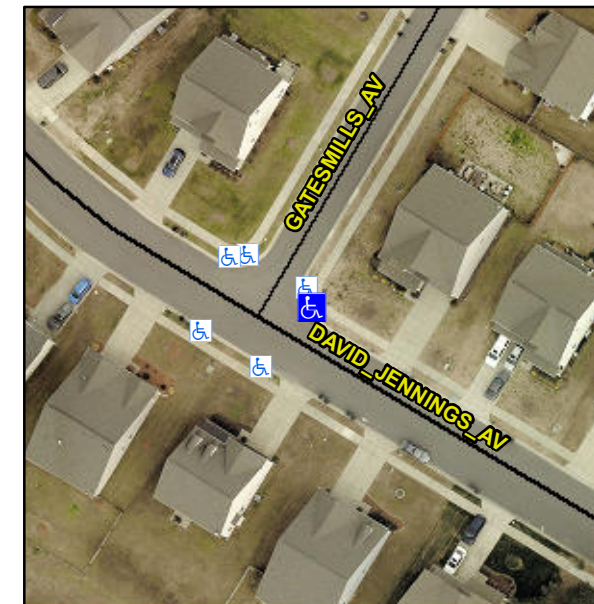
**Not Found, R304.5.3, R305.2, R304.5.4**

| Compliance | Description | Data | Compliance | Description | Data |
|---|---|---|---|---|---|
| No | Landing X Slope (%) | 2.3 | Yes | DWS Full Width? | Yes |
| N/A | Landing Curb? (Y/N) | No | No | DWS Offset (in) | 5.0 |
| Yes | Gutter Ponding? | No | No | Gutter Slope (%) | 7.7 |
| | | | No | Curb Slope (%) | 15.0 |

**Remove & Replace Curb Ramp With Two New Directional Ramps or Equivalent. Remove & Replace Gutter.**
