Access Compliance Report

Public Rights-of-Way (Curb Ramps)

Intersection ID: 51504	Main Street: DUNSLOW_CT	Cross Street: EASTFIELD_PARK_DR	Location: SW
ADA ID: A5BDBEA25C31	Ramp Type: Perp	Initial Pass/Fail: Fail	Overall Compliance: No
Severity Score: 22.5			
Codes/Mitigation Info/Possible Solution		Field Measurements/Component Compliance

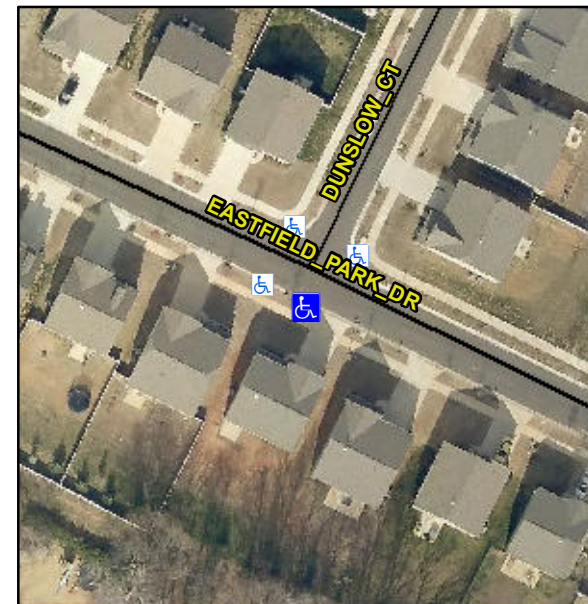
Not Found, R304.5.1, R304.2.2

Compliance	Description	Data	Compliance	Description	Data
N/A	Ramp Length (in)	71.0	No	Ramp Slope (%)	8.9
No	Ramp Width (in)	47.0	Yes	Ramp XSlope (%)	2.1
N/A	Flare Type LT	N/A	N/A	Flare Type RT	N/A
N/A	Flare Slope LT (%)	N/A	N/A	Flare Slope RT (%)	N/A
N/A	Flare Traversable LT?	N/A	N/A	Flare Traversable RT?	N/A
N/A	Landing Length (in)	N/A	N/A	DWS Provided?	N/A
N/A	Landing Width (in)	N/A	N/A	DWS Contrast?	N/A
N/A	Landing Slope (%)	N/A	N/A	DWS Length (in)	N/A
N/A	Landing X Slope (%)	N/A	N/A	DWS Full Width?	N/A
N/A	Landing Curb? (Y/N)	N/A	N/A	DWS Offset (in)	N/A
N/A	Shared Landing?	N/A			
N/A	Gutter Ponding?	N/A	N/A	Gutter Slope (%)	N/A
N/A	Gutter Lip Ht (in)	N/A	N/A	Gutter X Slope (%)	N/A
N/A	Painted X Walk1?	No	N/A	Painted X Walk2?	N/A
	X Walk 1 Direction	To NE		X Walk 2 Direction	N/A
N/A	X Walk 1 Width (in)	N/A	N/A	X Walk 2 Width (in)	N/A
	X Walk 1 Slope (%)	2.5		X Walk 2 Slope (%)	N/A
	X Walk 1 X Slope (%)	3.3		X Walk 2 X Slope (%)	N/A

N/A	Ramp inside XWalk1?	N/A	N/A	Ramp inside XWalk2?	N/A
	Road Slope (%)	N/A	N/A	Clear Space?	N/A
	Road X Slope (%)	N/A	N/A	Clear Space to XWalk (in)	N/A
N/A	Any Obstructions?	N/A	N/A	Storm Grate/Utility Hazard?	N/A
	Obstruction Type			Storm Grate/Utility Type	
		N/A			N/A
			Yes	Surface Condition? (G/P)	Good

Remove & Replace Entire Ramp.
