Access Compliance Report

Public Rights-of-Way

(Curb Ramps)

Intersection ID: 9571	Main Street: PEACEFUL_WAY_DR	Cross Street: RUSH_WIND_DR	Location: S
ADA ID: A5C428C1261A	Ramp Type: Perp	Initial Pass/Fail: Fail	Overall Compliance: No
Severity Score: 26.25			
Codes/Mitigation Info/Possible Solution		Field Measurements/Component Compliance

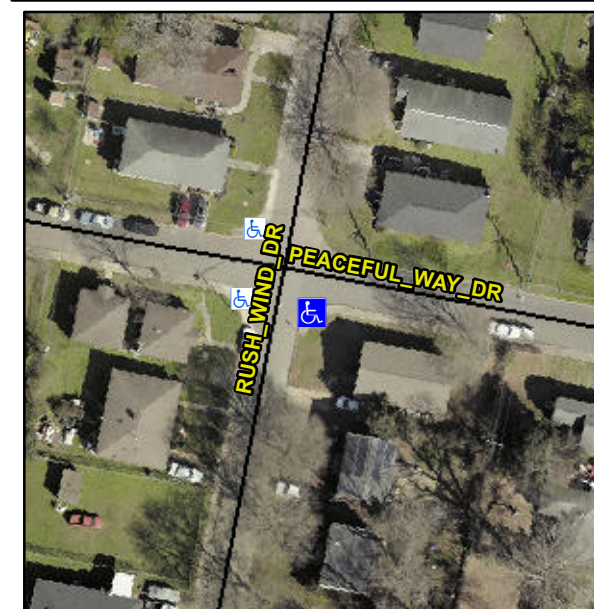
Compliance	Description	Data	Compliance	Description	Data
N/A	Ramp Length (in)	64.0	No	Ramp Slope (%)	14.8
Yes	Ramp Width (in)	53.0	No	Ramp XSlope (%)	4.7
N/A	Flare Type LT	N/A	N/A	Flare Type RT	N/A
N/A	Flare Slope LT (%)	N/A	N/A	Flare Slope RT (%)	N/A
N/A	Flare Traversable LT?	N/A	N/A	Flare Traversable RT?	N/A
N/A	Landing Length (in)	N/A	N/A	DWS Provided?	N/A
N/A	Landing Width (in)	N/A	N/A	DWS Contrast?	N/A
N/A	Landing Slope (%)	N/A	N/A	DWS Length (in)	N/A
N/A	Landing X Slope (%)	N/A	N/A	DWS Full Width?	N/A
N/A	Landing Curb? (Y/N)	N/A	N/A	DWS Offset (in)	N/A
N/A	Shared Landing?	N/A			
N/A	Gutter Ponding?	N/A	N/A	Gutter Slope (%)	N/A
N/A	Gutter Lip Ht (in)	0.5	N/A	Gutter X Slope (%)	N/A
N/A	Painted X Walk1?	No	N/A	Painted X Walk2?	N/A
	X Walk 1 Direction	To NW		X Walk 2 Direction	N/A
N/A	X Walk 1 Width (in)	N/A	N/A	X Walk 2 Width (in)	N/A
	X Walk 1 Slope (%)	0.3		X Walk 2 Slope (%)	N/A
	X Walk 1 X Slope (%)	2.3		X Walk 2 X Slope (%)	N/A

N/A	Ramp inside XWalk1?	N/A	N/A	Ramp inside XWalk2?	N/A
	Road Slope (%)	N/A	N/A	Clear Space?	N/A
	Road X Slope (%)	N/A	N/A	Clear Space to XWalk (in)	N/A
N/A	Any Obstructions?	N/A	N/A	Storm Grate/Utility Hazard?	N/A
	Obstruction Type			Storm Grate/Utility Type	
		N/A			N/A
			Yes	Surface Condition? (G/P)	Good

Possible Solutions:

Remove & Replace Entire Ramp.

R304.2.2, R304.5.3

\$ 1850.00
