Access Compliance Report

Public Rights-of-Way

(Curb Ramps)

| Intersection ID: 15205 | Main Street: CHEROKEE_RD | Cross Street: FENTON_PL | Location: SW |

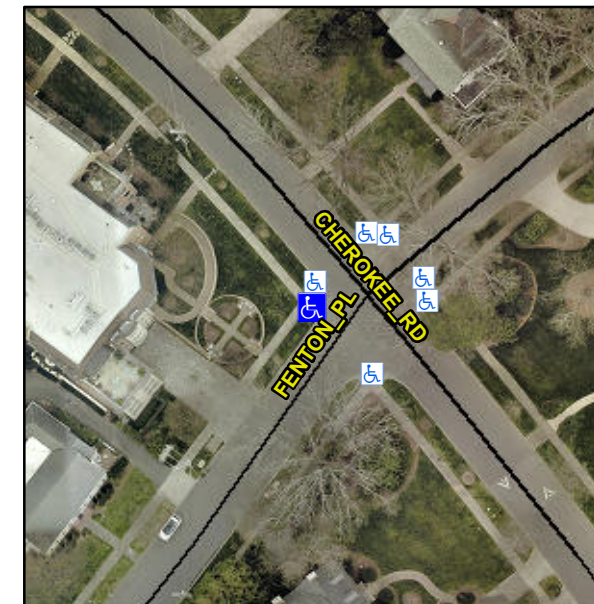
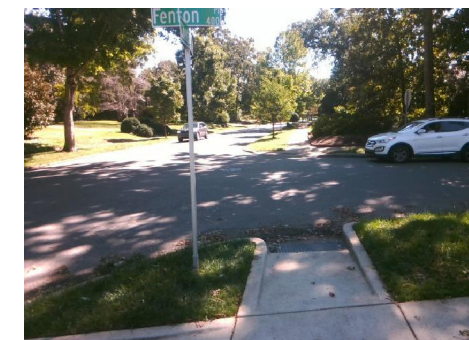
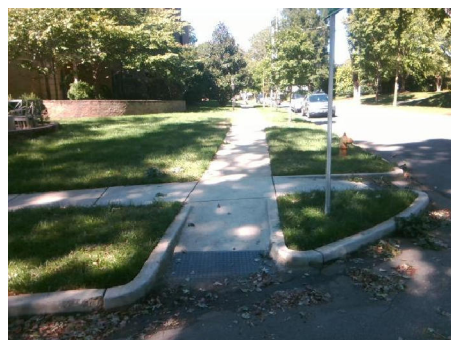
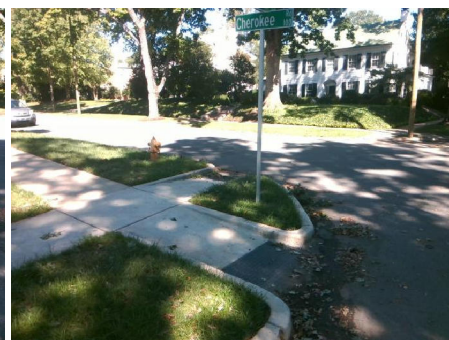
| ADA ID: A5CB8B43ABD9 | Ramp Type: Directional1 | Initial Pass/Fail: Fail | Overall Compliance: No |
| Severity Score: 22.5 | | | |

R304.5.1, R304.2.2, R304.5.3

| Compliance | Description | Data | Compliance | Description | Data |
|---|---|---|---|---|---|
| No | Ramp Width (in) | 47.0 | N/A | Grade Break Slope (%) | 0.0 |
| No | Ramp Slope (%) | 9.4 | N/A | Grade Break XSlope (%) | 0.0 |
| No | Ramp XSlope (%) | 2.4 | | | |

Remove & Replace Entire Ramp.
