Access Compliance Report

Public Rights-of-Way

(Curb Ramps)

Intersection ID: 14720	Main Street: E_5TH_ST	Cross Street: N_DOTGER_AV	Location: NE
ADA ID: A5CFB782AF3E	Ramp Type: Perp	Initial Pass/Fail: Fail	Overall Compliance: No
Severity Score: 1.25			
Codes/Mitigation Info/Possible Solution		Field Measurements/Component Compliance

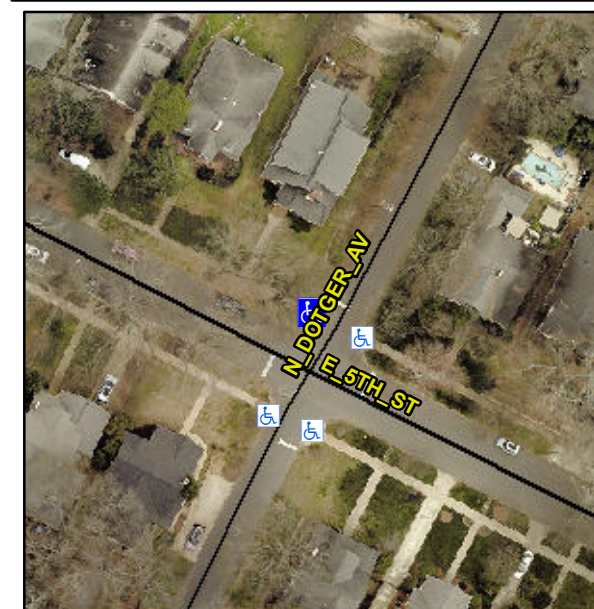
R304.5.3

Compliance	Description	Data	Compliance	Description	Data
N/A	Ramp Length (in)	34.0	Yes	Ramp Slope (%)	5.8
Yes	Ramp Width (in)	48.0	No	Ramp XSlope (%)	3.6
N/A	Flare Type LT	N/A	N/A	Flare Type RT	N/A
N/A	Flare Slope LT (%)	N/A	N/A	Flare Slope RT (%)	N/A
N/A	Flare Traversable LT?	N/A	N/A	Flare Traversable RT?	N/A
N/A	Landing Length (in)	N/A	N/A	DWS Provided?	N/A
N/A	Landing Width (in)	N/A	N/A	DWS Contrast?	N/A
N/A	Landing Slope (%)	N/A	N/A	DWS Length (in)	N/A
N/A	Landing X Slope (%)	N/A	N/A	DWS Full Width?	N/A
N/A	Landing Curb? (Y/N)	N/A	N/A	DWS Offset (in)	N/A
N/A	Shared Landing?	N/A			
N/A	Gutter Ponding?	N/A	N/A	Gutter Slope (%)	N/A
N/A	Gutter Lip Ht (in)	N/A	N/A	Gutter X Slope (%)	N/A
N/A	Painted X Walk1?	No	N/A	Painted X Walk2?	N/A
	X Walk 1 Direction	To SE		X Walk 2 Direction	N/A
N/A	X Walk 1 Width (in)	N/A	N/A	X Walk 2 Width (in)	N/A
	X Walk 1 Slope (%)	3.0		X Walk 2 Slope (%)	N/A
	X Walk 1 X Slope (%)	4.0		X Walk 2 X Slope (%)	N/A

Remove & Replace Entire Ramp.
