Access Compliance Report

Public Rights-of-Way

(Curb Ramps)

Intersection ID: N/A	Main Street: UNION_PACIFIC_AV	Cross Street: BELLE_VERNON_AV	Location: S
ADA ID: A5D2AE61BAE9	Ramp Type: PerpDiag	Initial Pass/Fail: Fail	Overall Compliance: No
Severity Score: 22.5			
Codes/Mitigation Info/Possible Solution		Field Measurements/Component Compliance

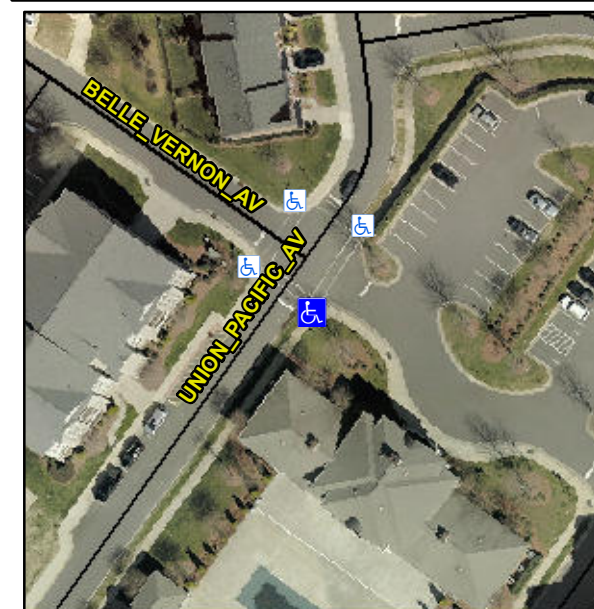
Not Found, R304.5.1, R304.2.2, R304.5.3

Compliance	Description	Data	Compliance	Description	Data
N/A	Ramp Length (in)	35.0	No	Ramp Slope (%)	8.8
No	Ramp Width (in)	47.0	No	Ramp XSlope (%)	2.2
N/A	Flare Type LT	N/A	N/A	Flare Type RT	N/A
N/A	Flare Slope LT (%)	N/A	N/A	Flare Slope RT (%)	N/A
N/A	Flare Traversable LT?	N/A	N/A	Flare Traversable RT?	N/A
N/A	Landing Length (in)	N/A	N/A	DWS Provided?	N/A
N/A	Landing Width (in)	N/A	N/A	DWS Contrast?	N/A
N/A	Landing Slope (%)	N/A	N/A	DWS Length (in)	N/A
N/A	Landing X Slope (%)	N/A	N/A	DWS Full Width?	N/A
N/A	Landing Curb? (Y/N)	N/A	N/A	DWS Offset (in)	N/A
N/A	Shared Landing?	N/A			
N/A	Gutter Ponding?	N/A	N/A	Gutter Slope (%)	N/A
N/A	Gutter Lip Ht (in)	N/A	N/A	Gutter X Slope (%)	N/A
N/A	Painted X Walk1?	Yes	N/A	Painted X Walk2?	Yes
	X Walk 1 Direction	To NE		X Walk 2 Direction	To NW
N/A	X Walk 1 Width (in)	59.0	N/A	X Walk 2 Width (in)	55.2
	X Walk 1 Slope (%)	0.6		X Walk 2 Slope (%)	1.6
	X Walk 1 X Slope (%)	3.9		X Walk 2 X Slope (%)	0.4

N/A	Ramp inside XWalk1?	Yes	N/A	Ramp inside XWalk2?	Yes
	Road Slope (%)	1.8	N/A	Clear Space?	N/A
	Road X Slope (%)	3.3	N/A	Clear Space to XWalk (in)	N/A
N/A	Any Obstructions?	N/A	N/A	Storm Grate/Utility Hazard?	N/A
	Obstruction Type			Storm Grate/Utility Type	
		N/A			N/A
		Yes		Surface Condition? (G/P)	Good

Possible Solutions:

Remove & Replace Curb Ramp With Two New Directional Ramps or Equivalent.
